Bridge-Bear Phase 4

Grant Number- 218-6032-16061

Post Implementation Status Report #1

7/31/2023

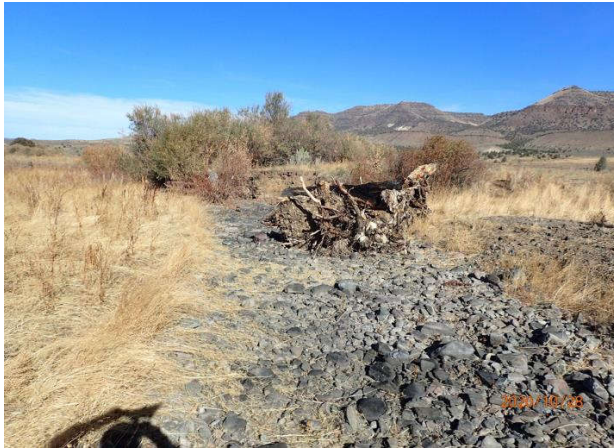
Above: Photo Point #1- showing large woody debris.

After: Large woody debris still in place.

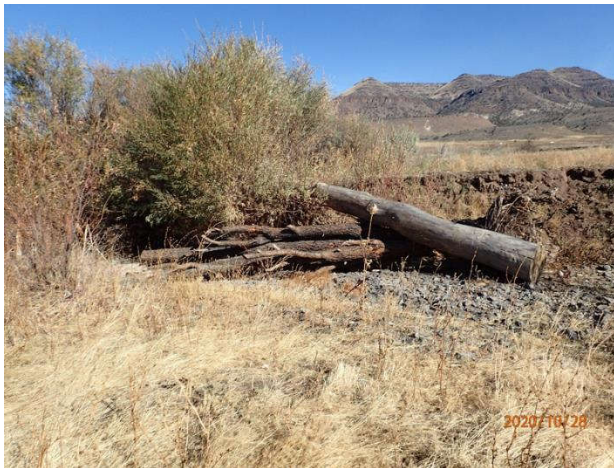
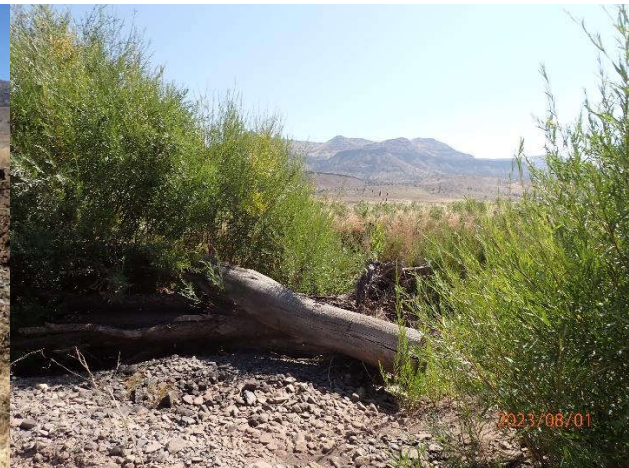
Above: Photo Point #2- Large woody debris placed against bank to create scour pool and habitat.

After: Large woody debris still remains and evidence of scour pool is present during higher flow times.

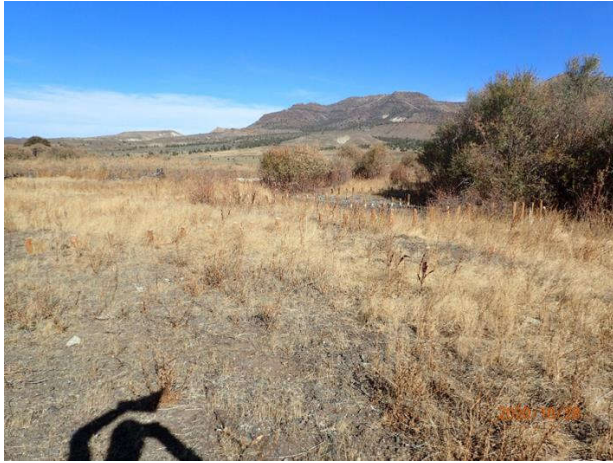
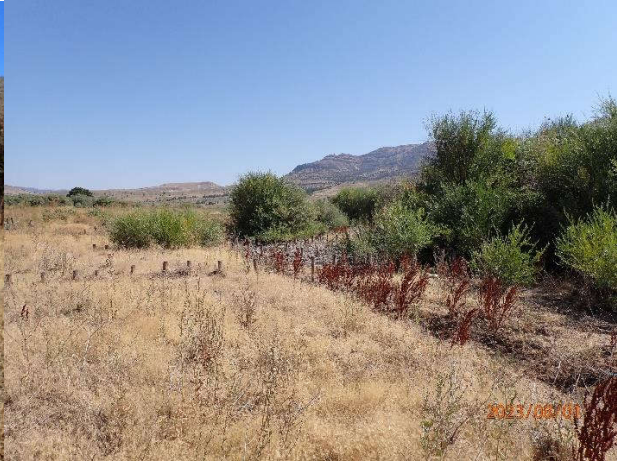
Above: Photo Point #3- Overview of BDA structures.

After: BDA structures still in place.

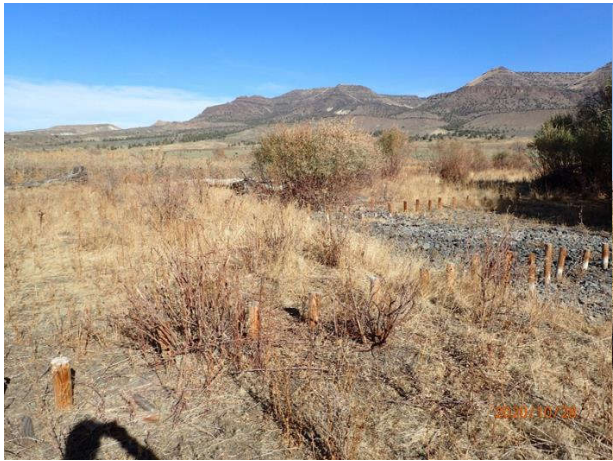
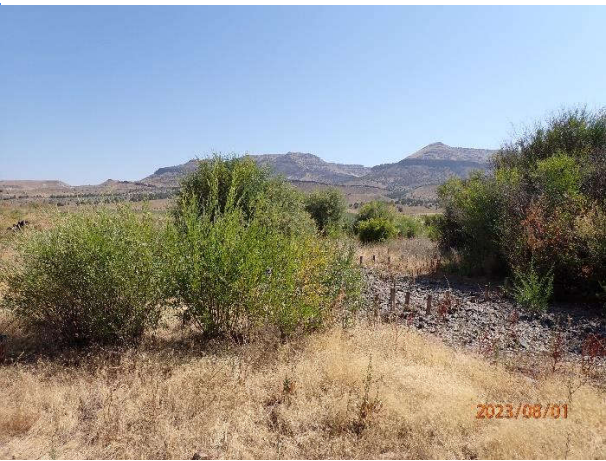
Above: Photo Point #4- Close up of BDA structures throughout channel and floodplain.

After: BDA still present in flow channel and floodplain.

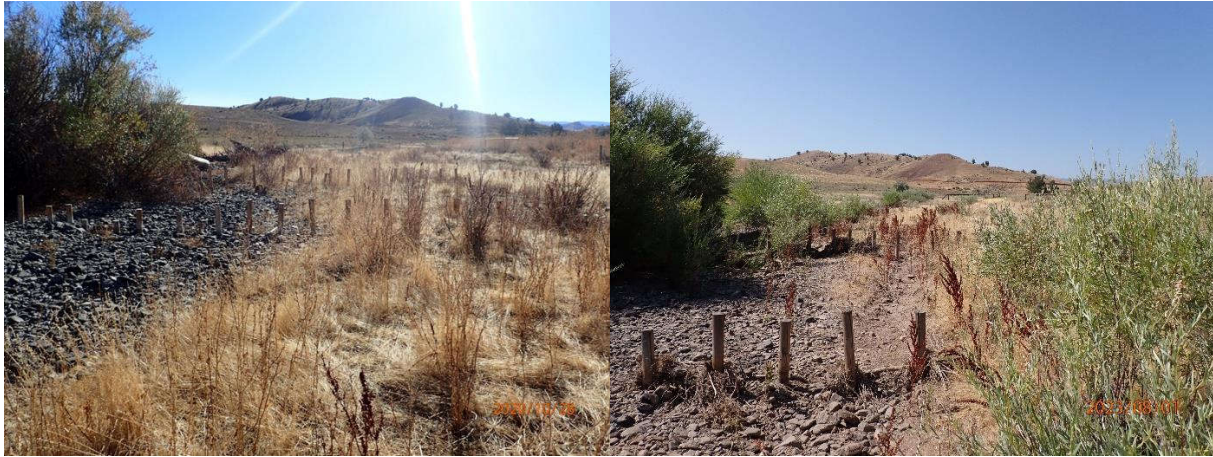
Above: Photo Point #5- Overview of BDA structures in Bear Creek.

After: BDA still present in Bear Creek.

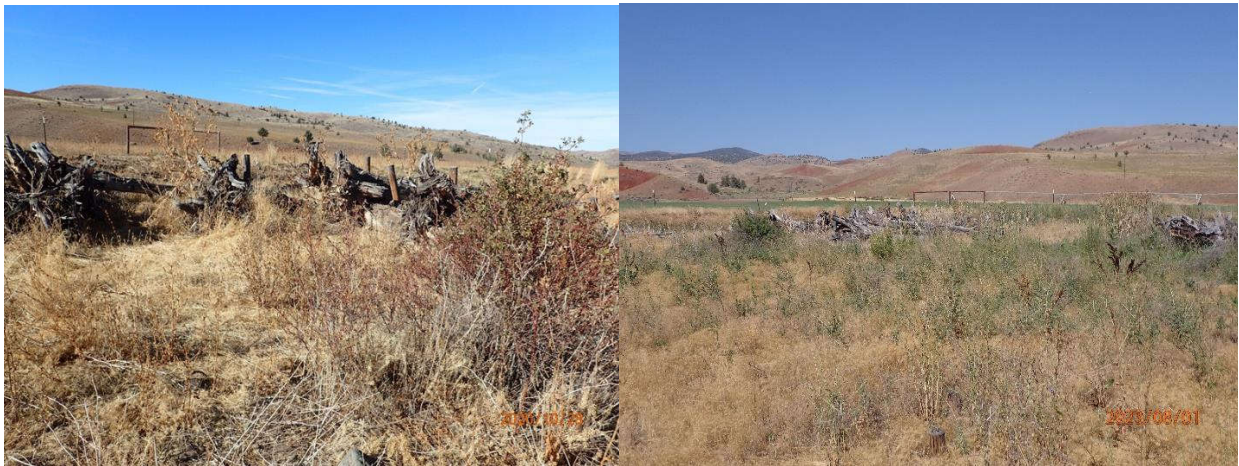
Above: Photo Point #6- View of large woody debris in floodplain.

After: Large woody debris still present in floodplain.

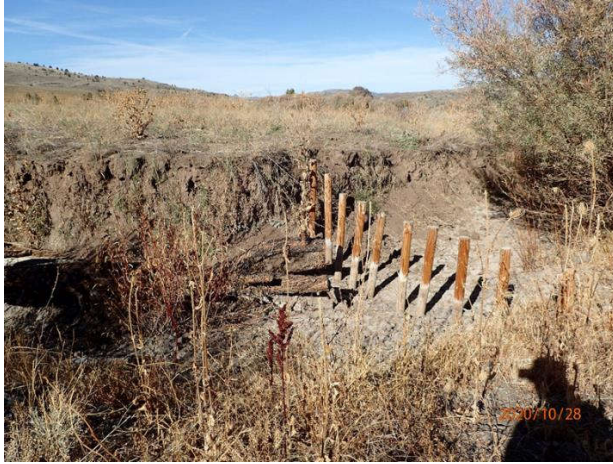
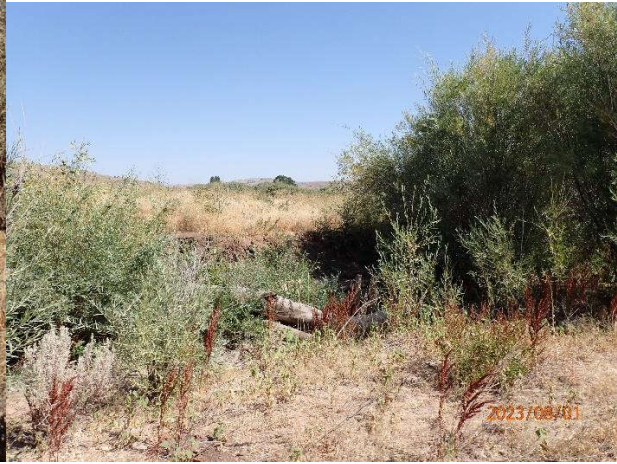
Above: Photo Point #7- Overview of BDA structure and large woody debris.

After: BDA and large woody debris still present with increased vegetation.

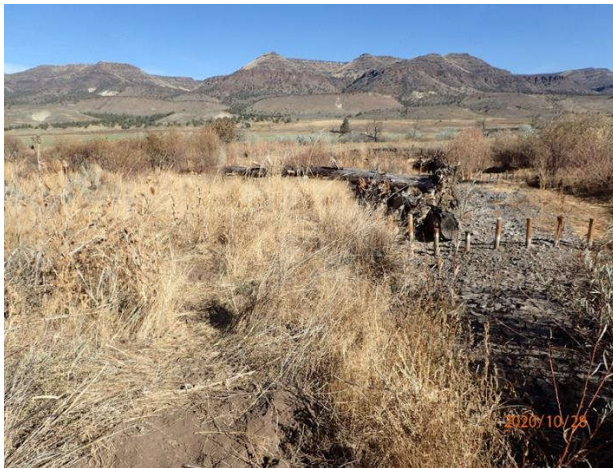
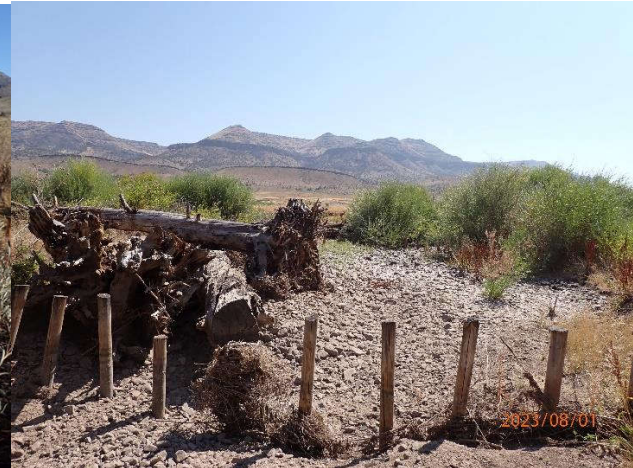
Above: Photo Point #8- Landscape view of BDA structures and large woody debris.

After: Landscape of BDA structures still present with large woody debris still in place.

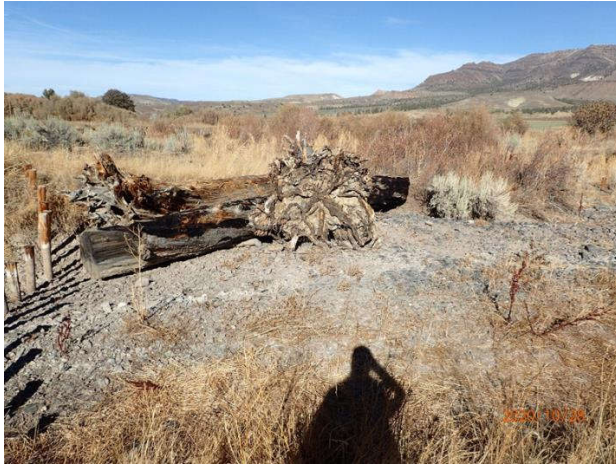
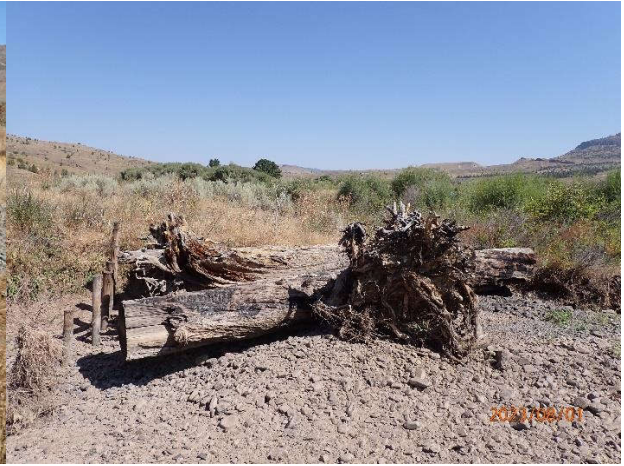
Above: Photo Point #9- Close up of large woody debris.

After: Large woody debris still present.

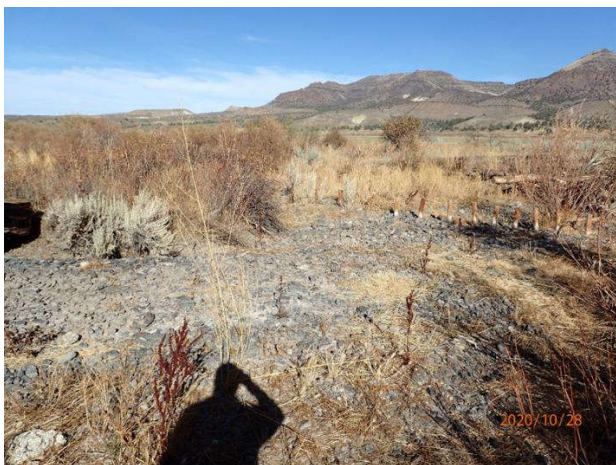
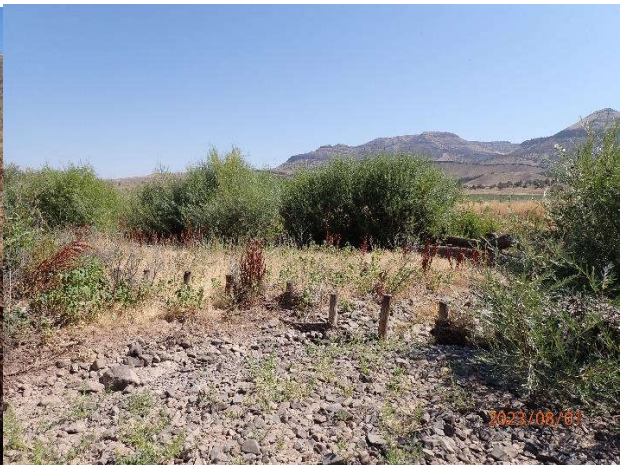
Below: Photo Point #10- . Overview of BDA structure in Bear Creek.

After: BDA structure still present in Bear Creek.

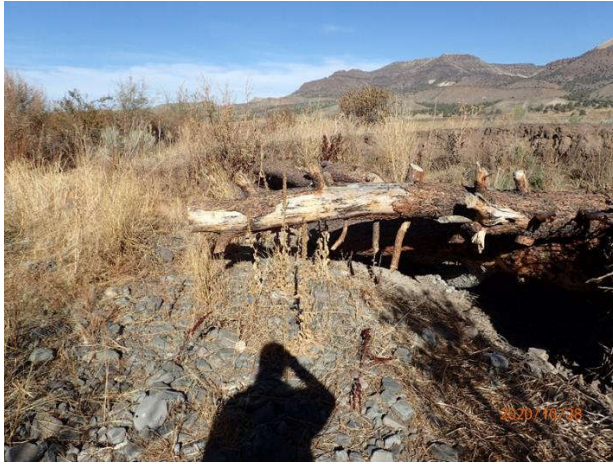
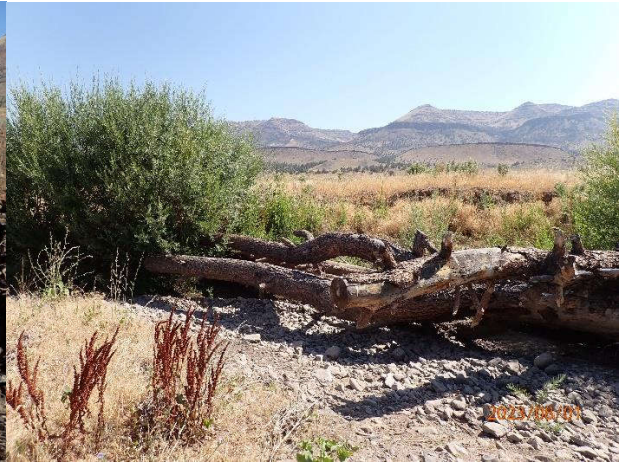
Above: Photo Point #11- Showing large woody debris creating scour pool and habitat.

After: Large woody debris still in place, no water present to create scour pool.

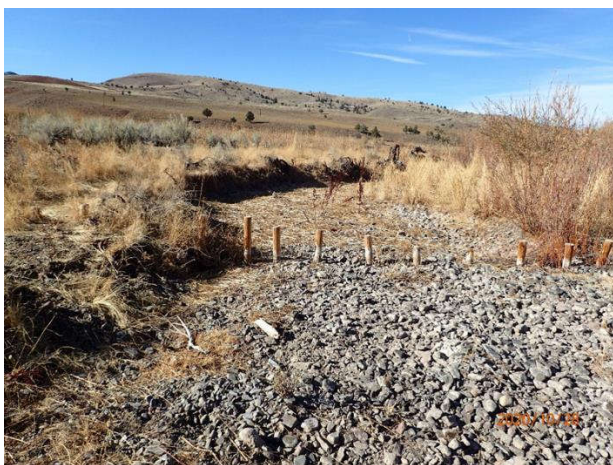
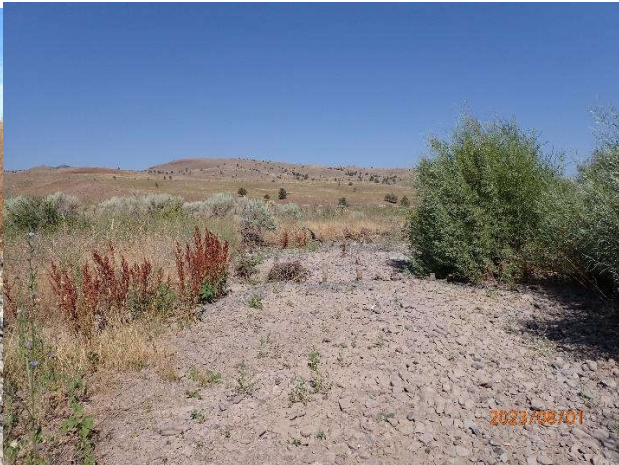
Above: Photo Point #12- Landscape view of BDA structures in stream channel.

After: BDA structures still present in channel.

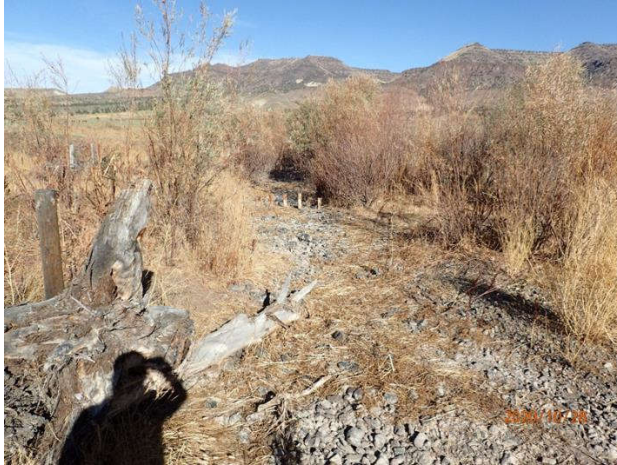
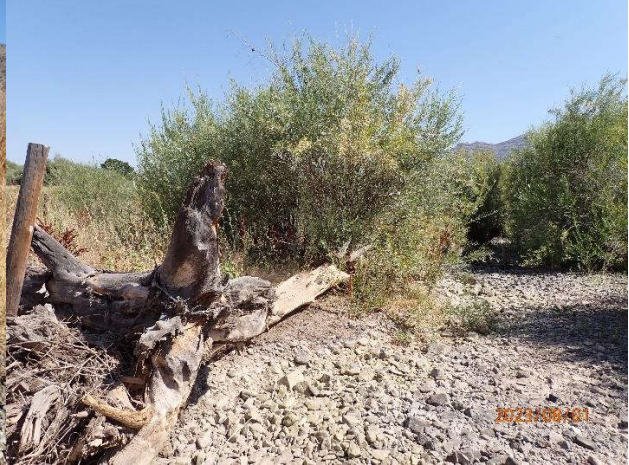
Above: Photo Point #13- Overview of BDA structure and large woody debris.

After: Large woody debris shifted some during high flow, and BDA still present.

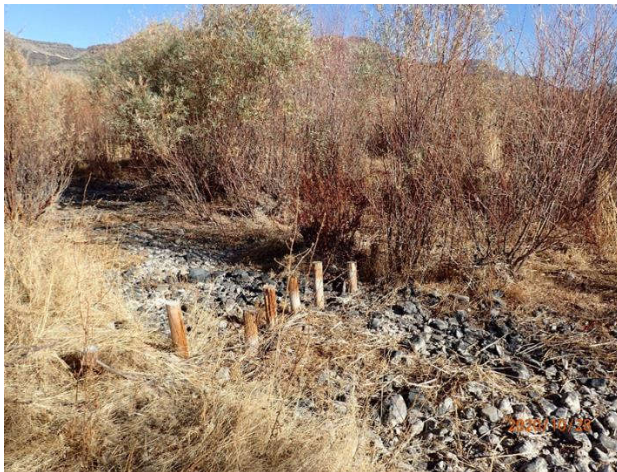
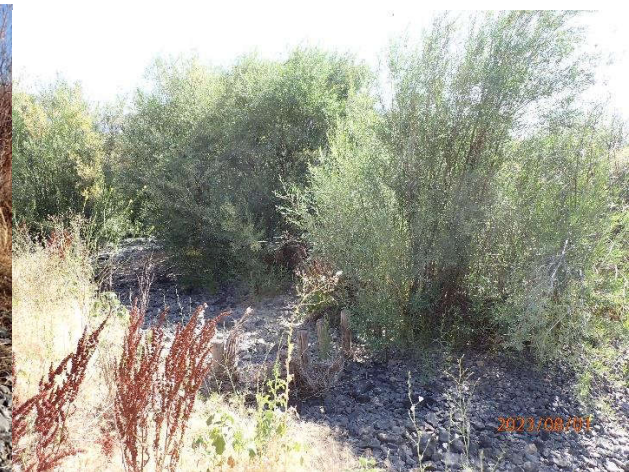
Above: Photo Point #14- Close up of BDA structure with riparian plant species thriving.

After: BDA structure still present with riparian species continuing to thrive.

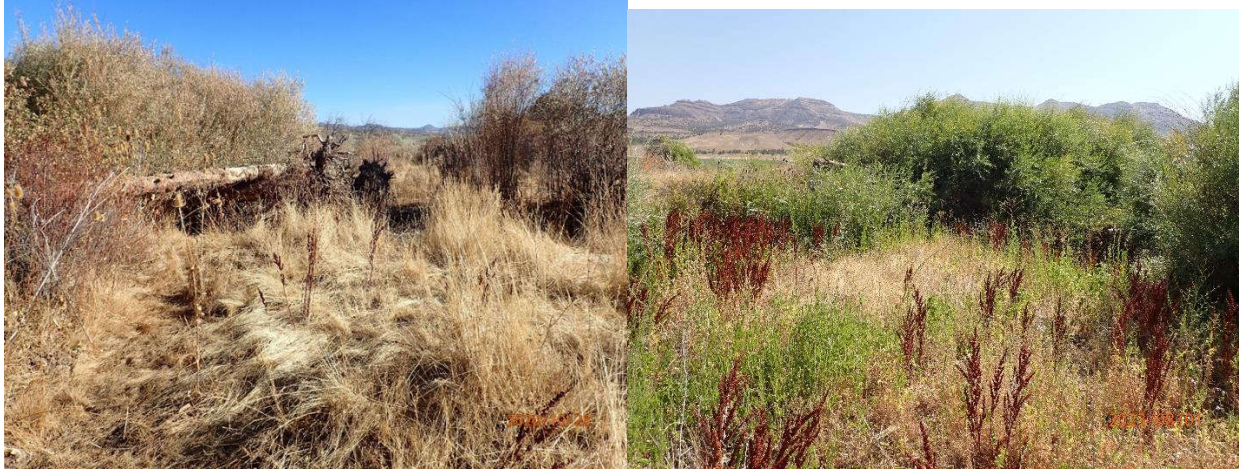
Above: Photo Point #15- View of large woody debris.

After: Vegetation has grown over large woody debris that is still present.

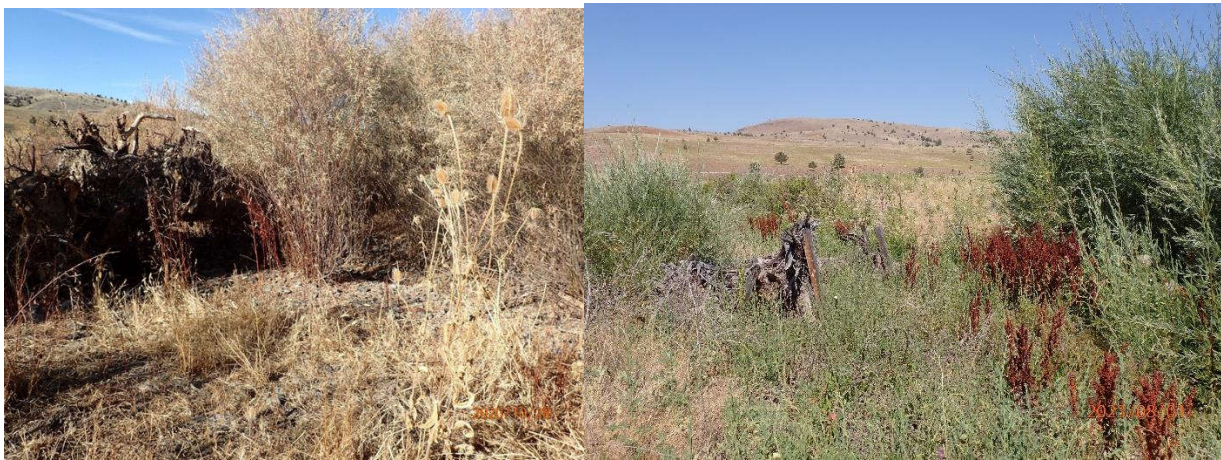
Above: Photo Point #16- Large woody debris and riparian species providing adequate habitat.

After: Large woody debris and riparian species continuing to provide habitat.

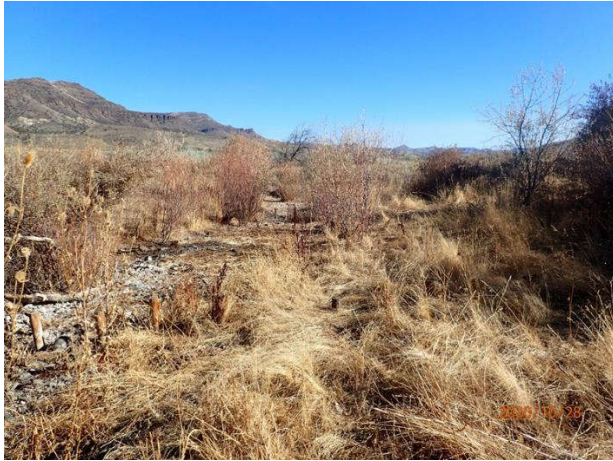
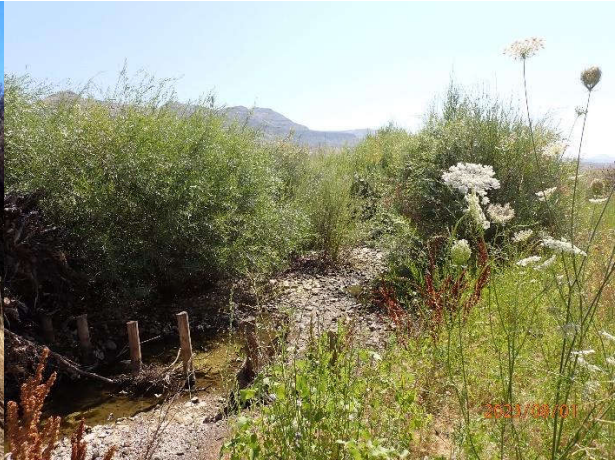
Above: Photo Point #17- Overview of BDA structures in Bear Creek.

After: BDA structures still present.

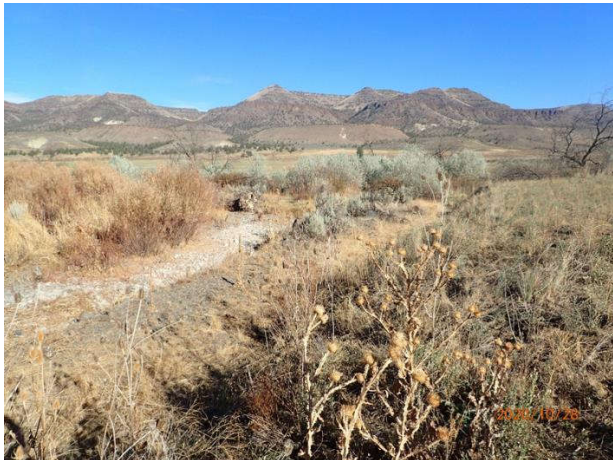
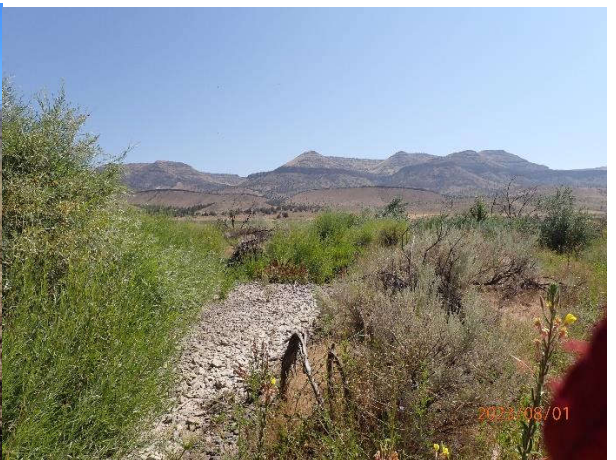
Above: Photo Point #18- Landscape view of large woody debris.

After: Large woody debris still present.

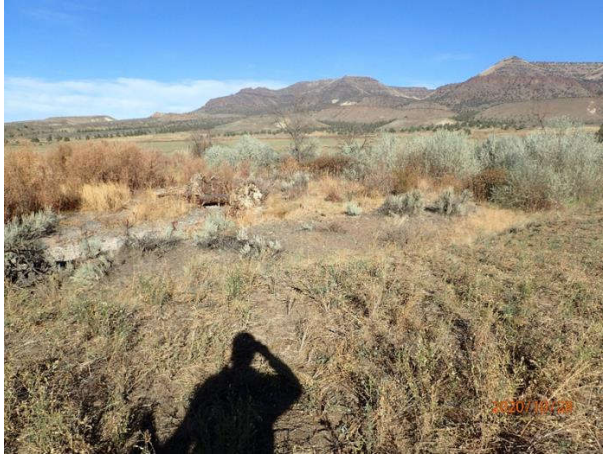
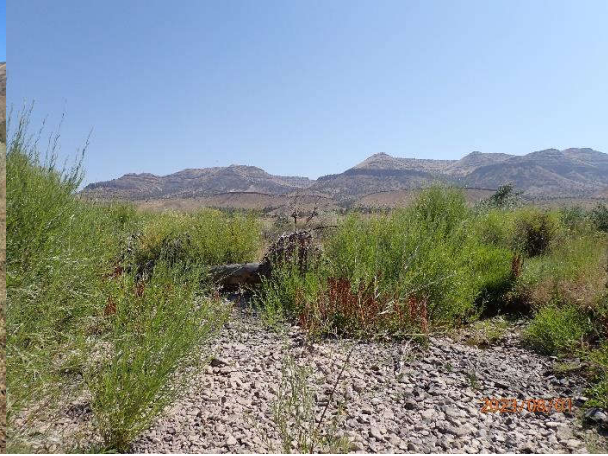
Above: Photo Point #19- Close up of large woody debris in Bear Creek.

After: Large woody debris still present.

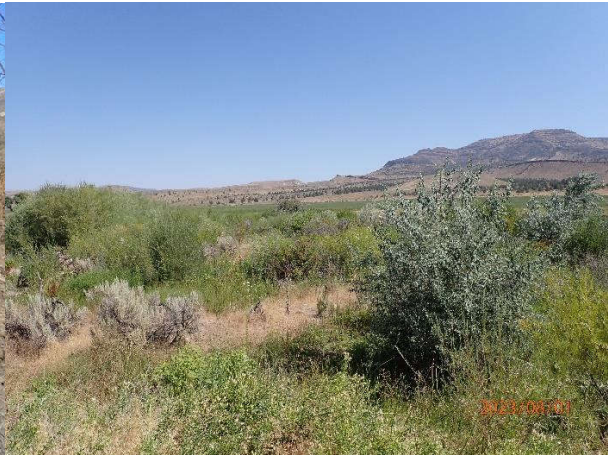
Above: Photo Point #20- View of BDA structure surrounded by riparian species.

After: Riparian species thriving, with BDA still present.

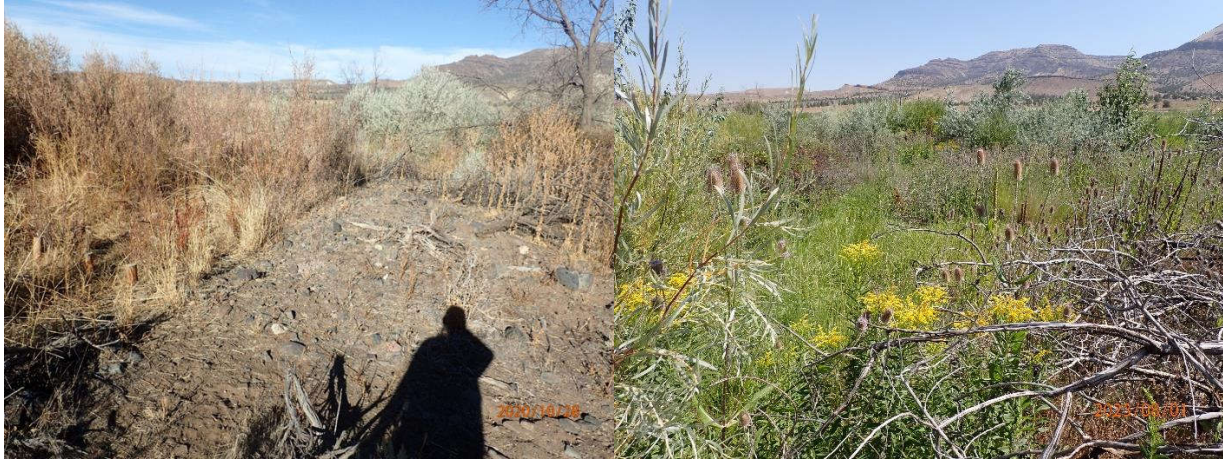
Above: Photo Point #21- Close up of BDA structure and woody species along riparian area.

After: Vegetation thriving, with BDA still present.

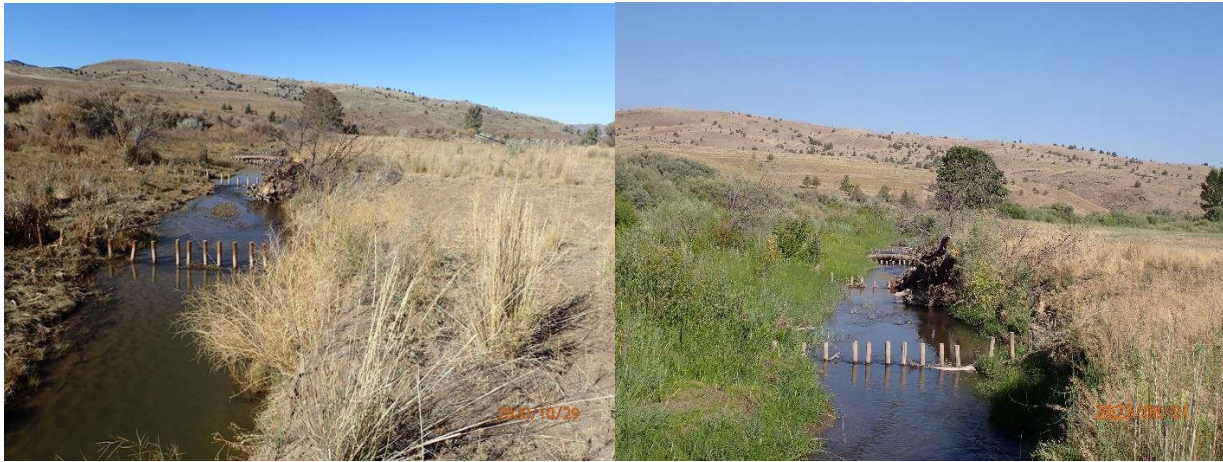
Above: Photo Point #22- Landscape view of BDA structures throughout Bridge Creek.

After: Vegetation thriving with BDAs continuing to be effective.

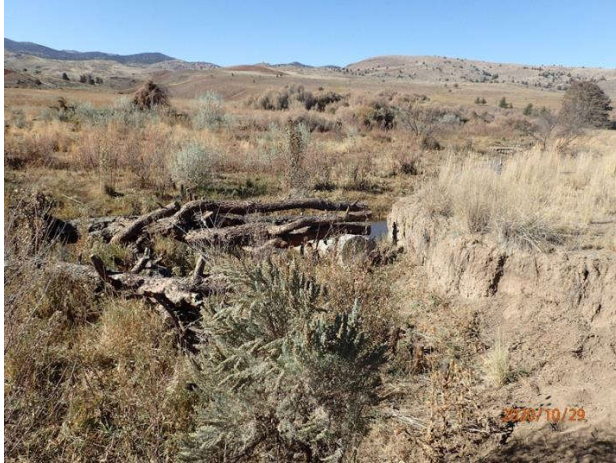
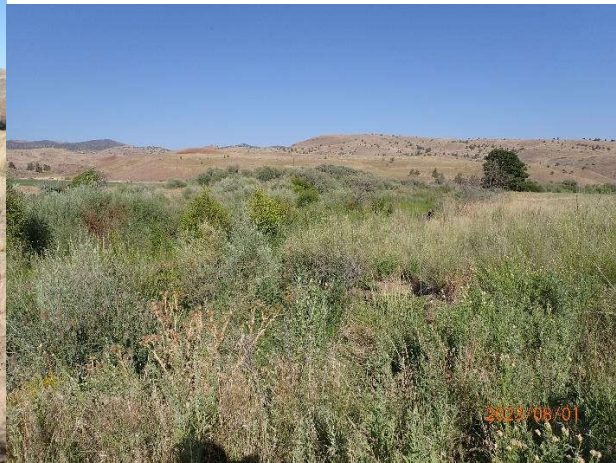
Above: Photo Point #23- Close up of large woody debris providing additional habitat.

After: Vegetation thriving and woody debris is still present.

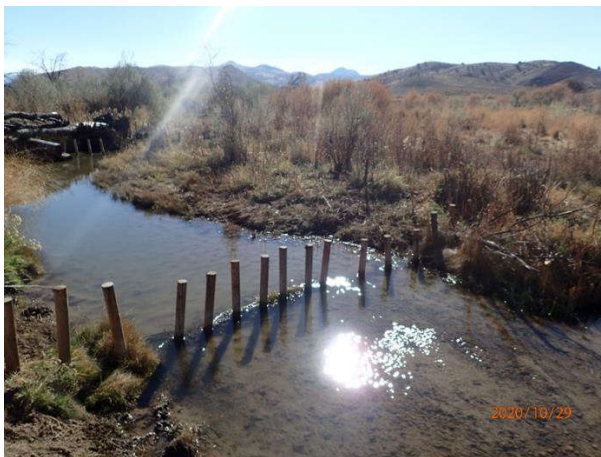
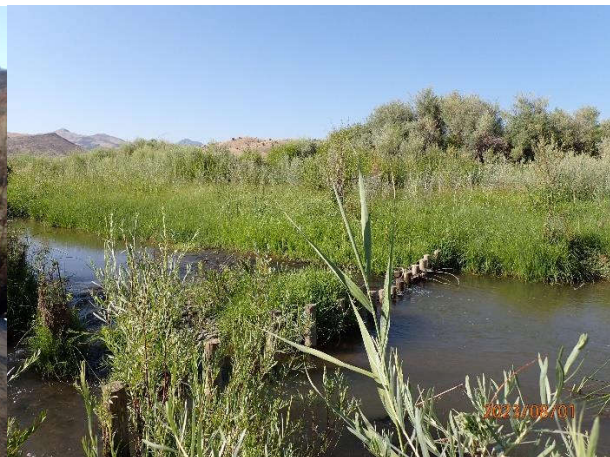
Above: Photo Point #24- View of BDA structures and large woody debris in the background.

After: BDA with thriving vegetation and large woody debris.

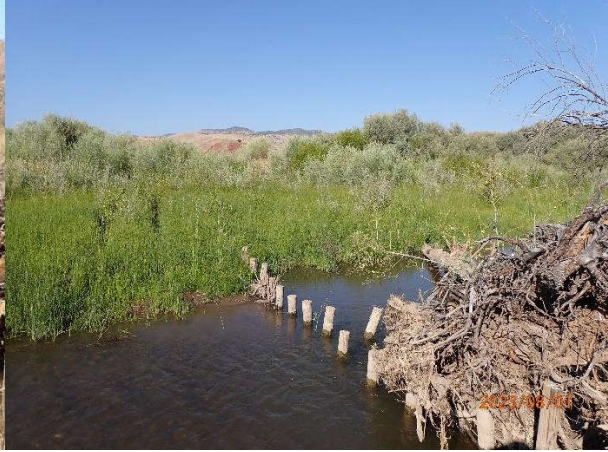
Above: Photo Point #25- Showing BDA structure across Bridge Creek and into the floodplain.

After: BDA structure still present in creek and floodplain.

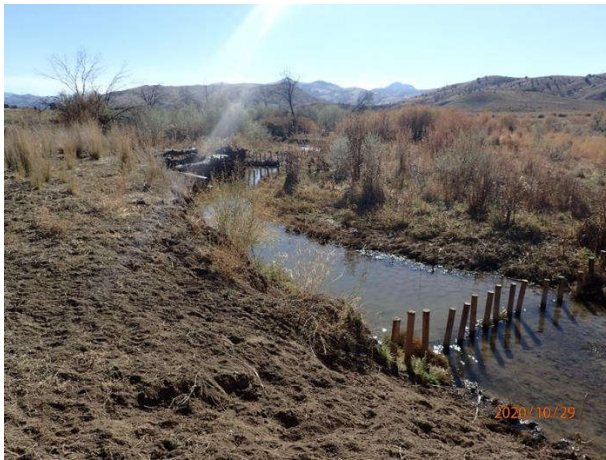
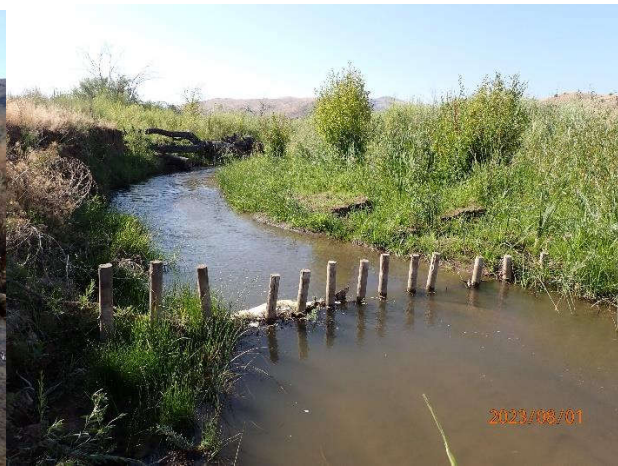
Above: Photo Point #26- Landscape view of BDA structures and large woody debris.

After: Effective BDA and large woody debris still present.

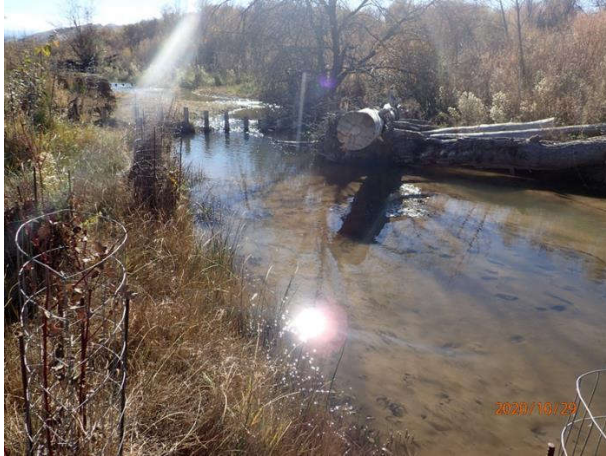
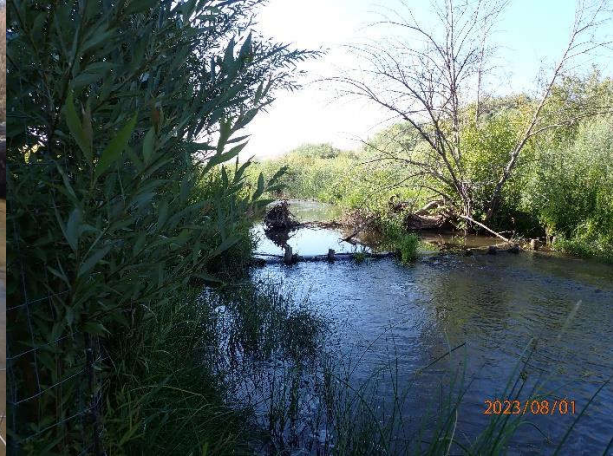
Above: Photo Point #27- Showing riparian planting, BDA structure, and large woody debris.

After: BDA with Beaver activity.

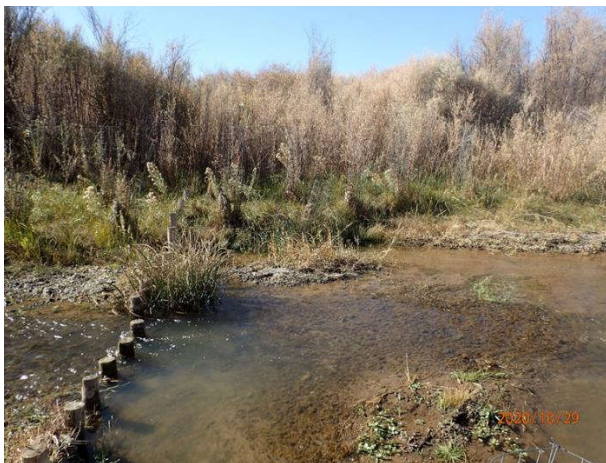
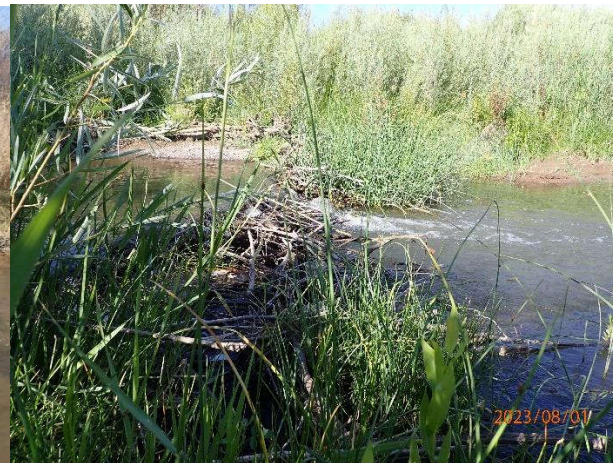
Above: Photo Point #28- Overview of BDA structure spreading water into the floodplain.

After: BDA with Beaver activity continuing to spread water into floodplain.

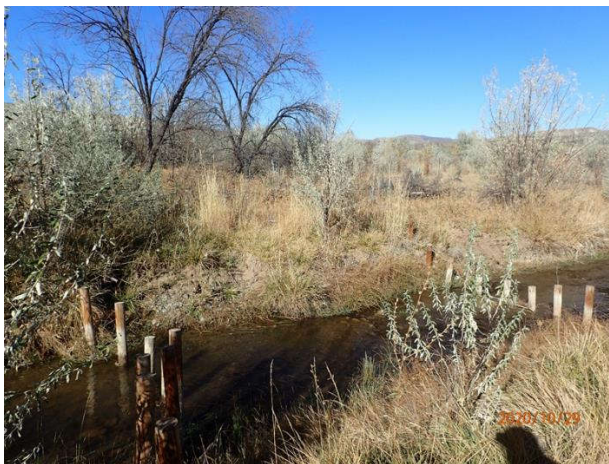
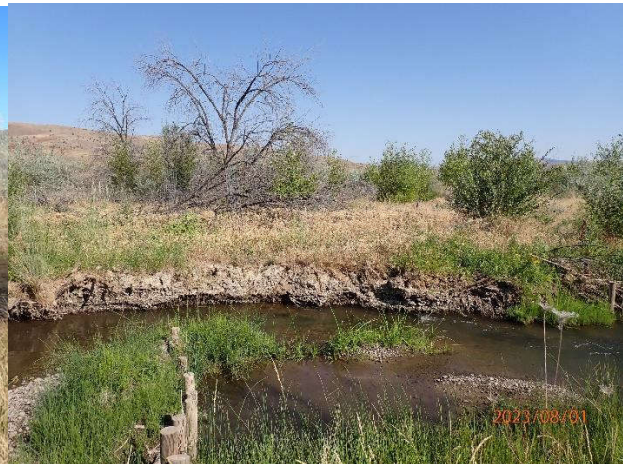
Above: Photo Point #30- Close up of BDA structures on Bridge Creek.

After: Close up of BDA with vegetation thriving.

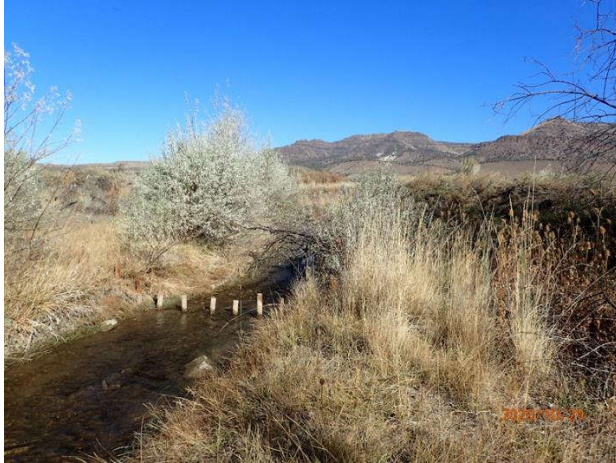
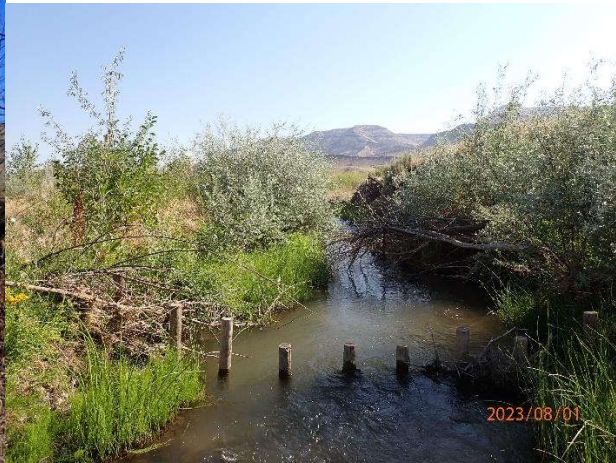
Above: Photo Point #31- Overview of BDA structures creating floodplain connectivity.

After: BDA structures with floodplain connectivity.

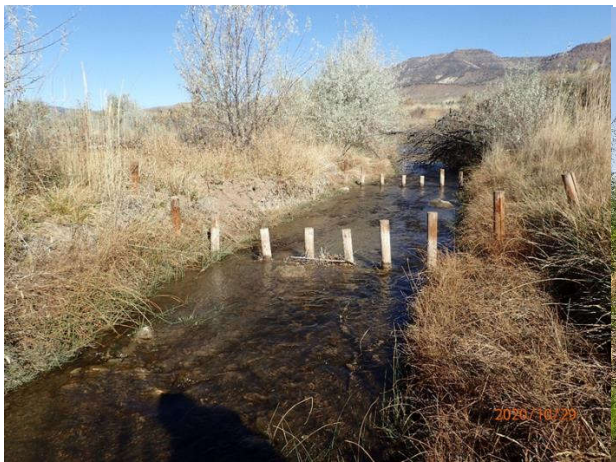
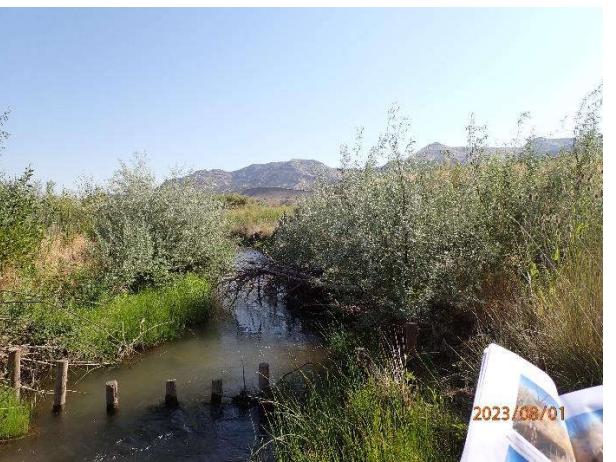
Above: Photo Point #32- Landscape view of BDA structures and riparian vegetation.

After: BDA structures with thriving vegetation.

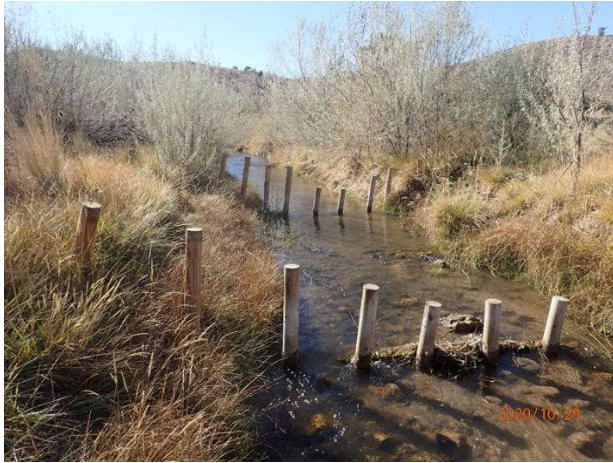
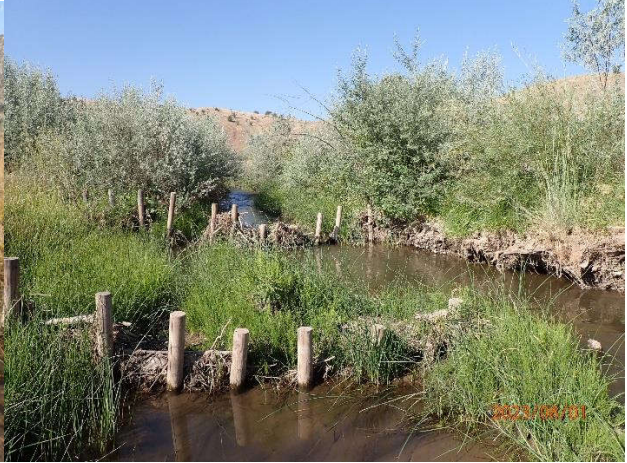
Above: Photo Point #33- Close up of BDA structures, riparian species, and vegetation.

After: Effective BDAs with thriving Vegetation.

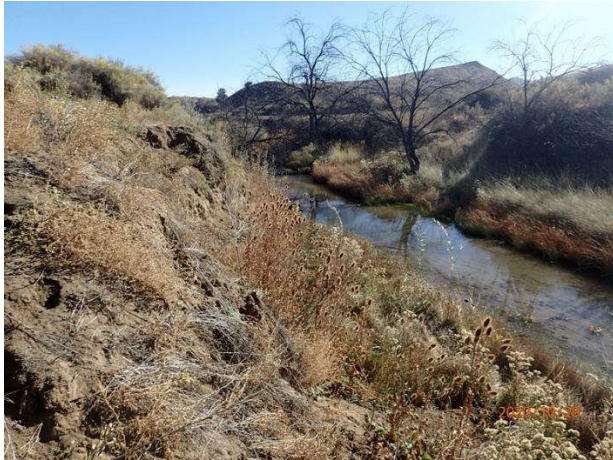
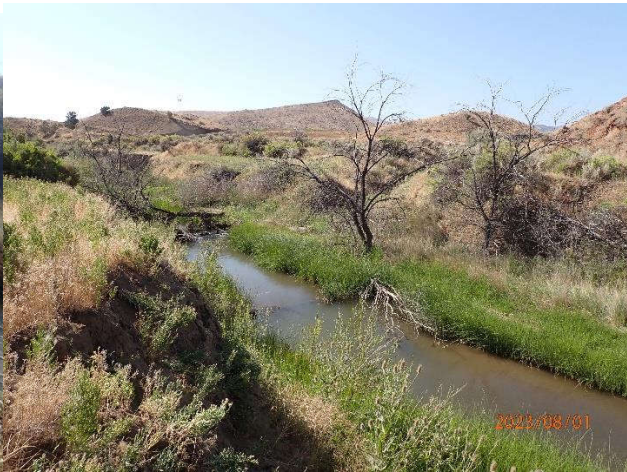
Above: Photo Point #34- Overview of BDA structures. One partially silted in.

After: BDA still silted in.

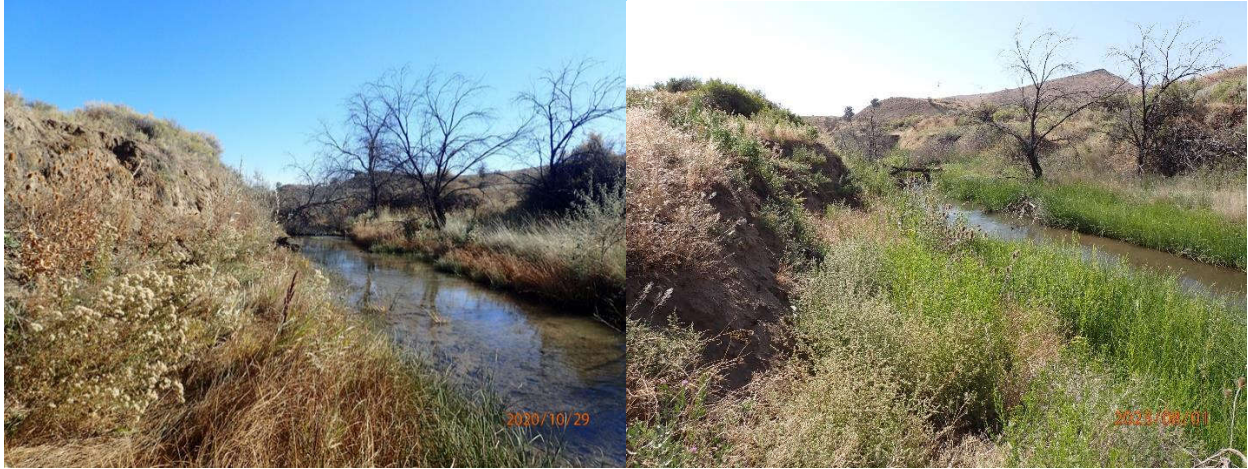
Above: Photo Point #35- Landscape view of BDA structures connecting floodplain.

After: BDA structures connecting floodplain.

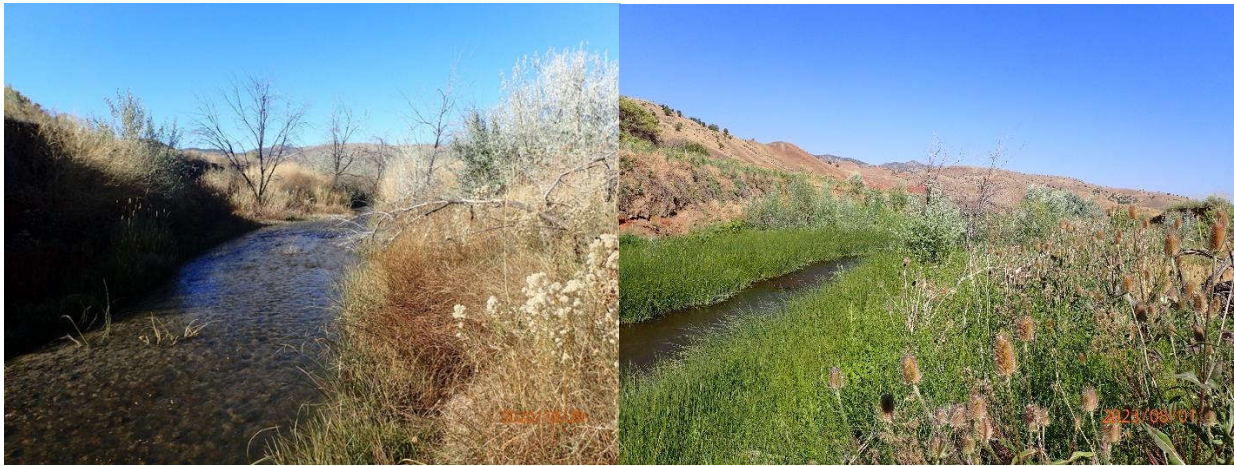
Above: Photo Point #36- Showing deposition from BDA structures upstream.

After: Deposition from BDAs looking upstream.

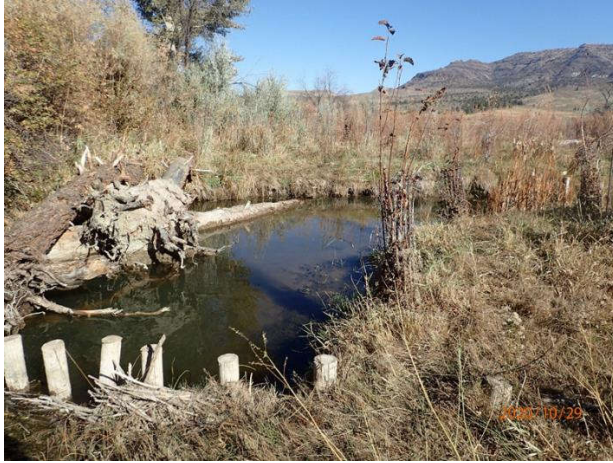
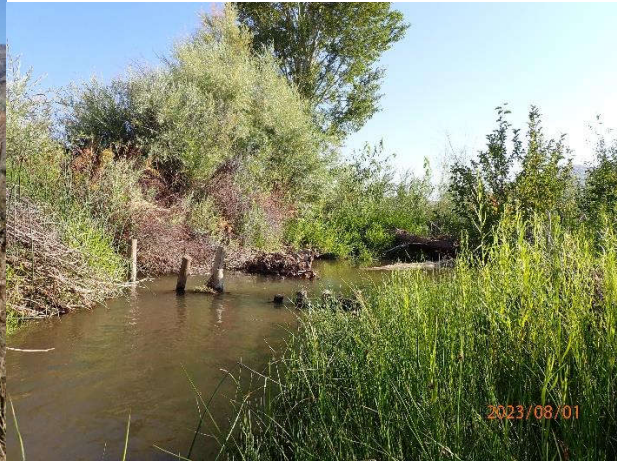
Above: Photo Point #37- Close up of BDA structure and large woody debris creating scour pool.

After: BDA structure silted in and large woody debris shifted with high flow, but still creating scour pool.

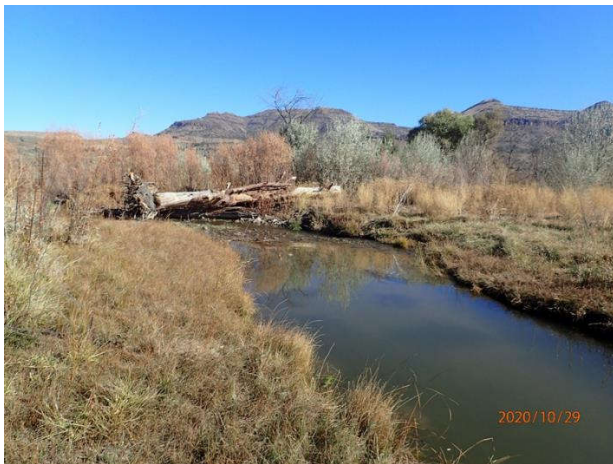
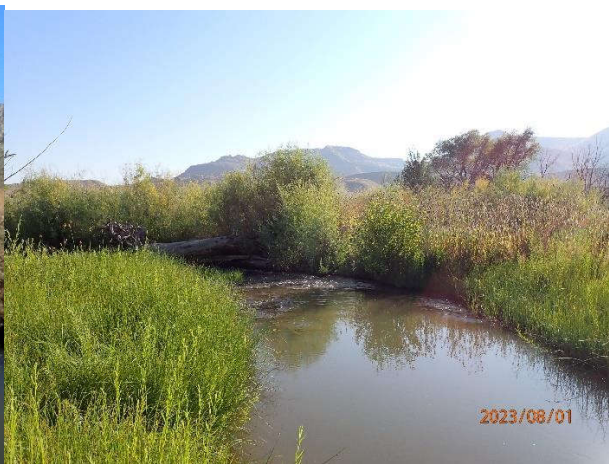
Above: Photo Point #38- View of large woody debris creating fish habitat past the glide.

After: Large woody debris continuing to create fish habitat.

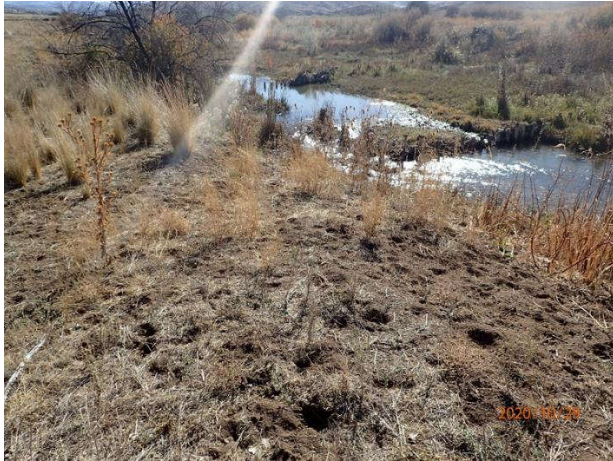
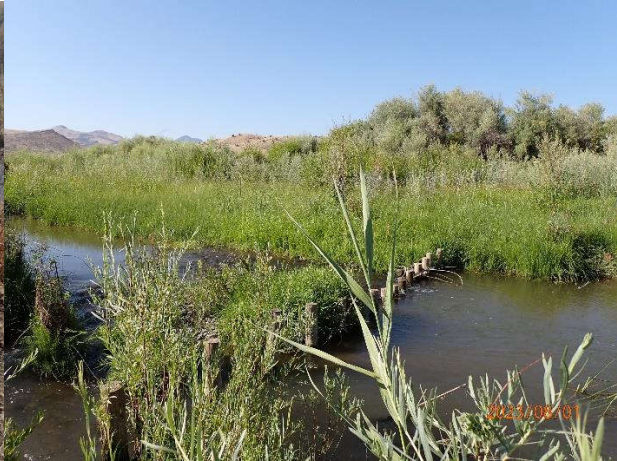
Above: Photo Point #39- Overview of BDA structures capturing debris.

After: BDA still present and capturing debris.

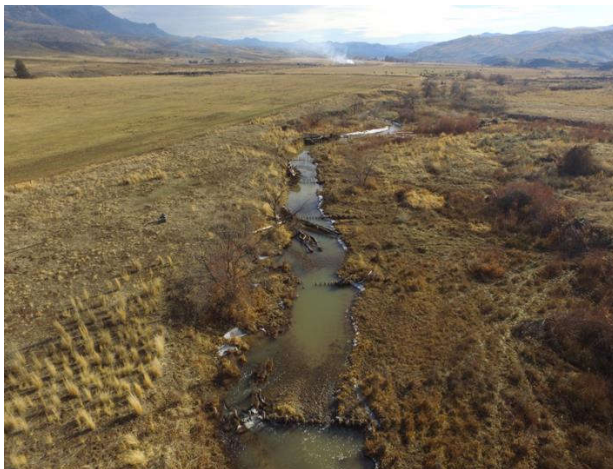
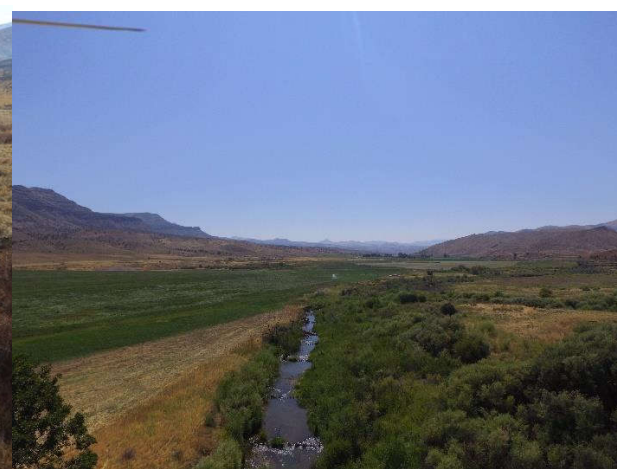
Above: Photo Point #40- Aerial image showing repaired BDA's and LWD placement. Located near photo point 27.

After: Vegetation is thriving.
