Bridge-Bear Phase 4

Grant Number- 218-6032-16061

Post Implementation Status Report #1

7/31/2023

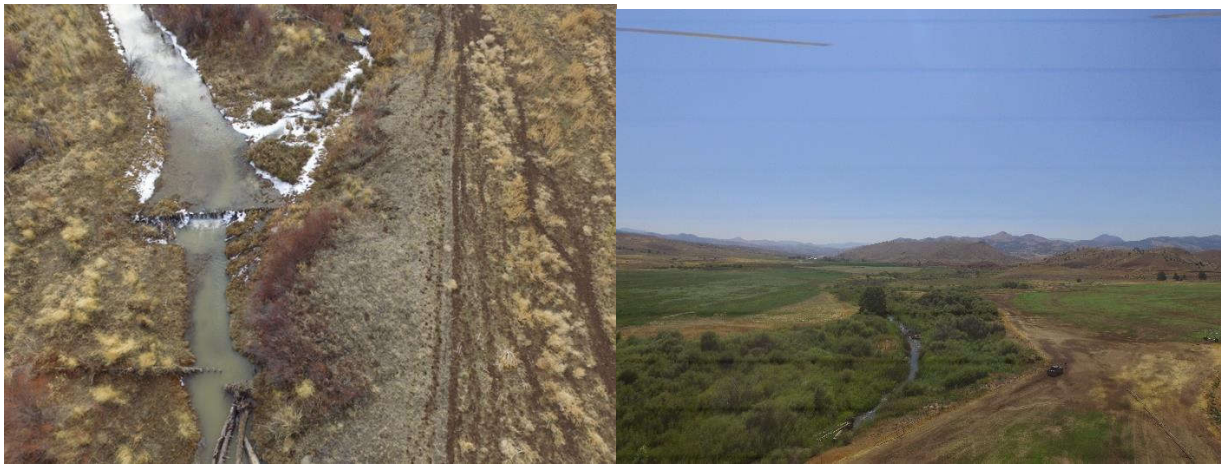
Above: Photo Point #41- Aerial image showing where failed BDA on the end of the creek left side right below the big BDA structure. A log was placed in the hole as part of the LWD placement. High flow events have altered wood placement pushing the LWD slightly downstream from hole placement.

After: Large woody debris continues to shift, but still effective. Vegetation continues to thrive.

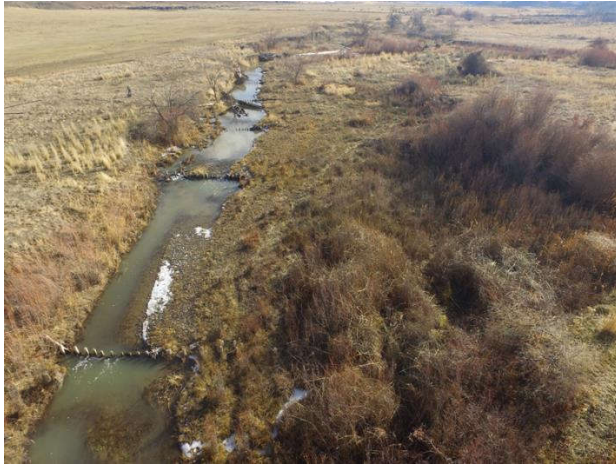
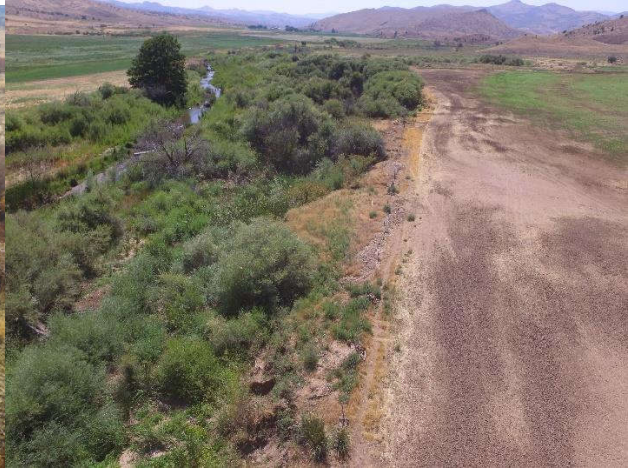
Above: Photo Point #42- Aerial image showing all project elements; BDA structures, repaired BDA structures, and LWD placement. Located near photo point 27.

After: Vegetation continues to thrive, BDA structures and large woody debris is still present.
