Middle Bear Creek BDA Restoration Project

Grant Number – 217- 6044 - 14238

Post Implementation Status Report #1

Date: 5/26/2022

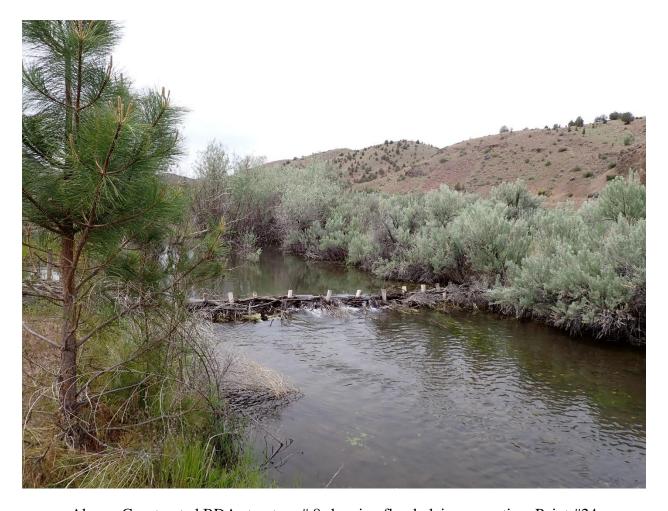
Above: Constructed BDA structure # 8 showing flood plain connection. Point #24

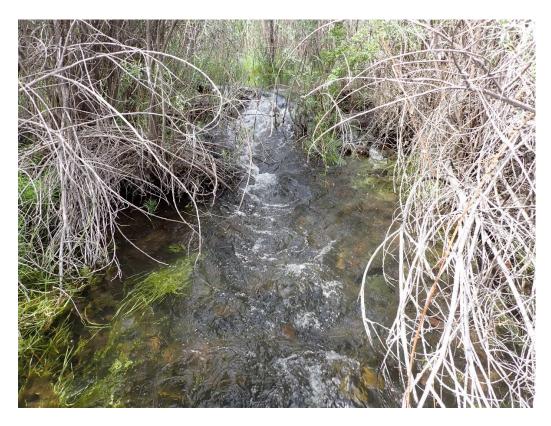
Above: Riffle below BDA treatment. Point #1

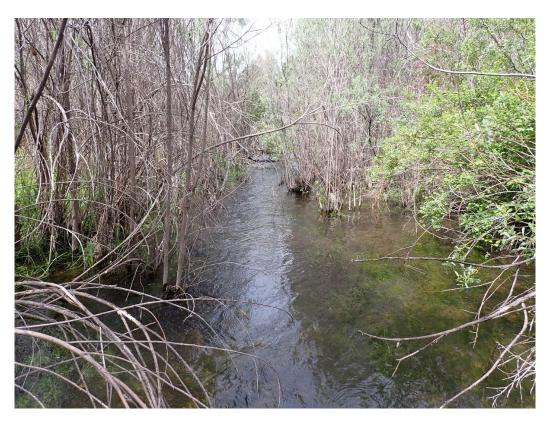
Below: Riffle below BDA treatment. Point #2

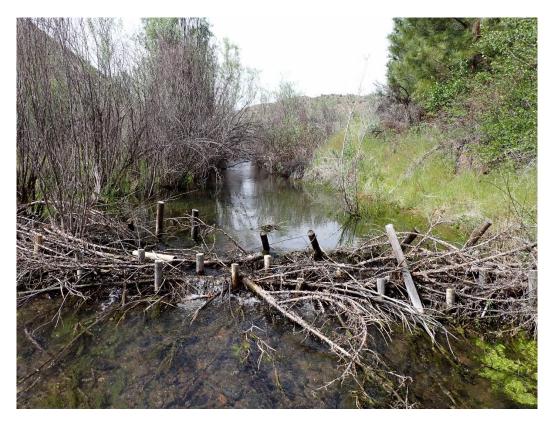
Above: BDA structure expanding stream bank and increasing pooling. Point #3

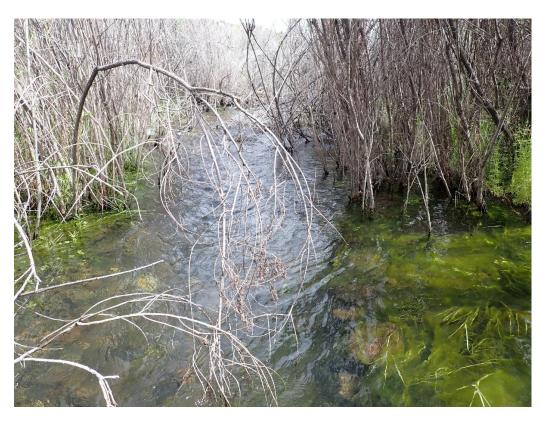
Below: BDAs installed near the bottom of a riffle. Point #4

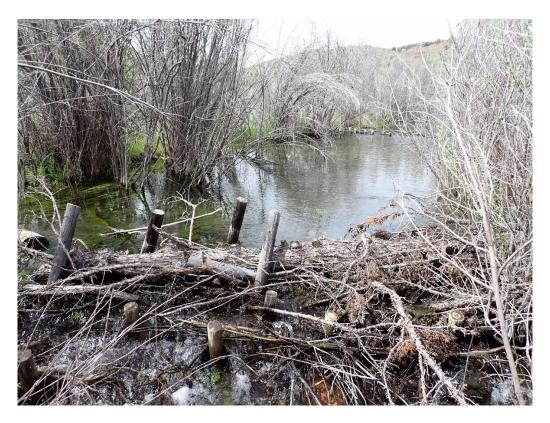
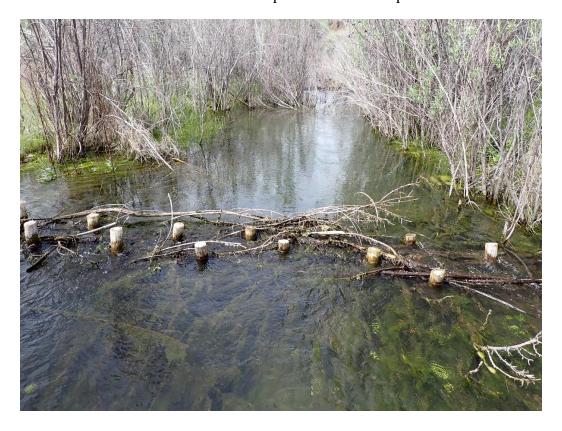
Above: BDA installed at the bottom of a lateral scour pool. Point #5 Below: BDA installed at the top of a lateral scour pool. Point #6

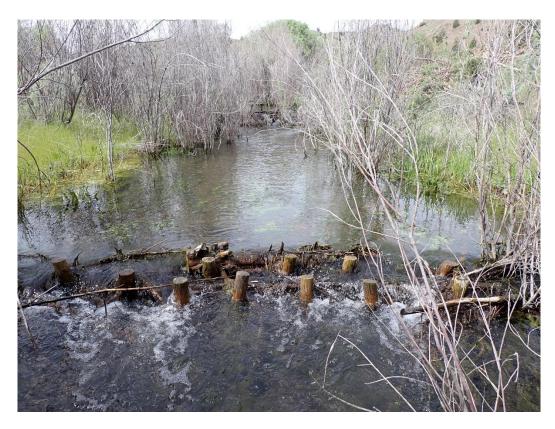
Above: View of BDA installed at a glide. Point #7

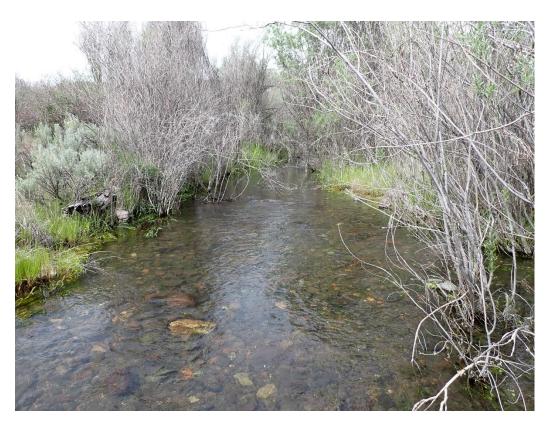
Above: A straight scour pool upstream from BDA. Point #9

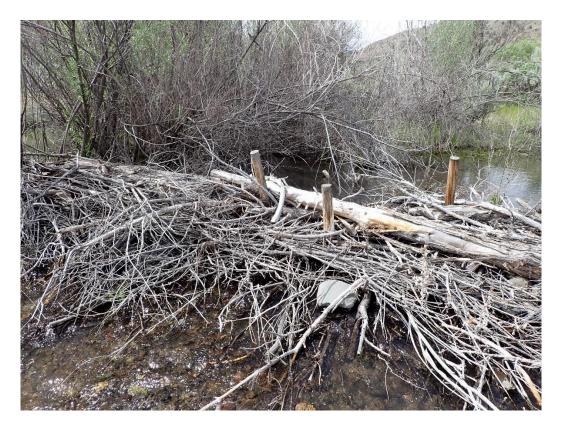
Above: A BDA installed at a glide. Point #11

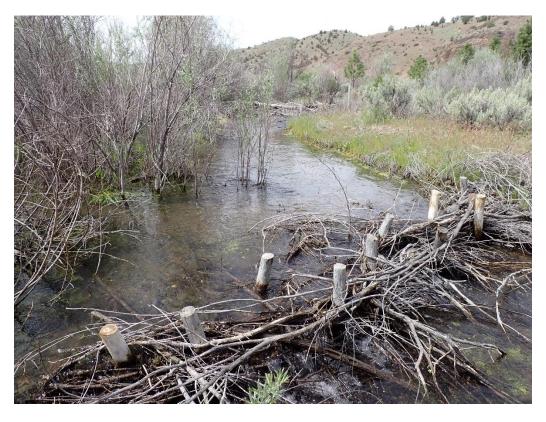
Below: Another angle taken of same BDA. Point #12

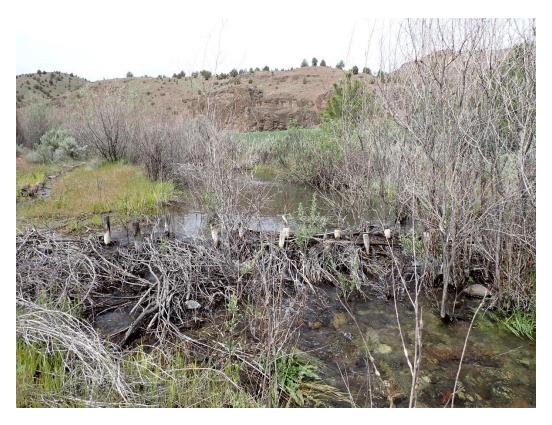
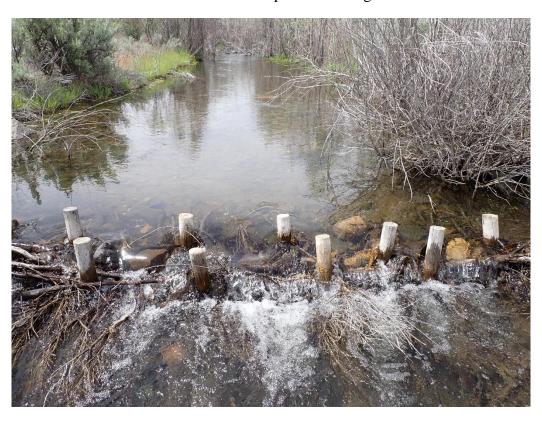
Above: View of BDA structure from bottom of a long glide. Point #13 Below: Photo taken near the top of the same glide. Point #14

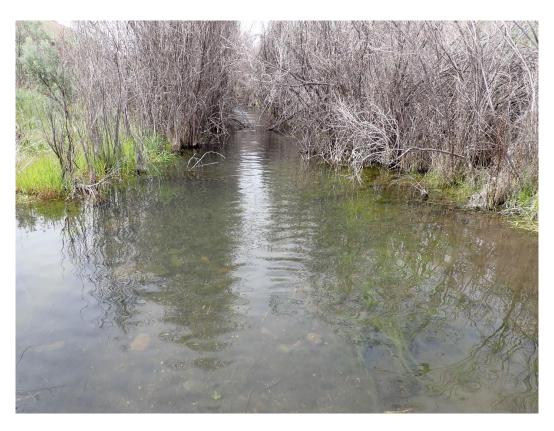
Above: Straight scour pool created by BDA. Point #15

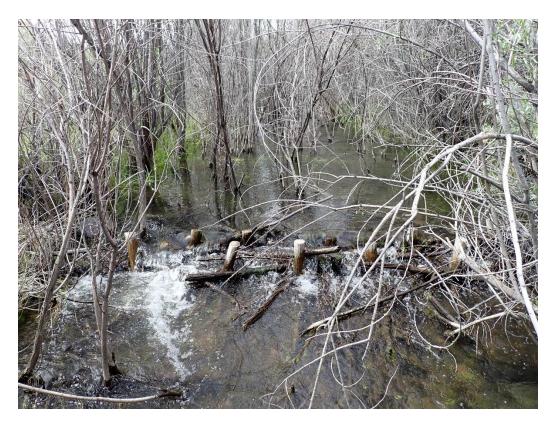
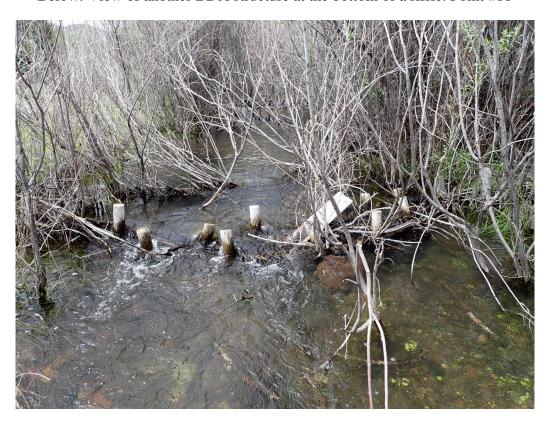
Above: BDA near bottom of a riffle with willows creating lots of shade. Point #17 Below: View of another BDA structure at the bottom of a riffle. Point #18

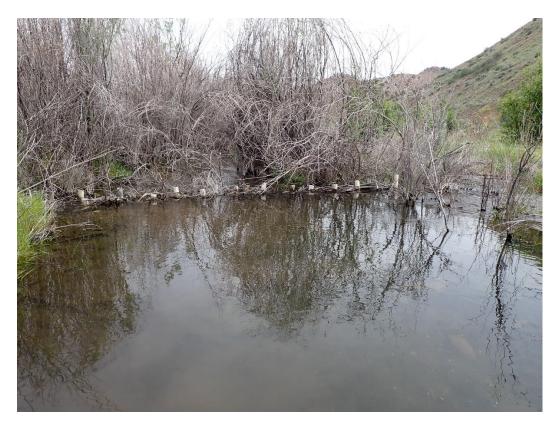
Above: Backwater pool created by BDA structure #1. Point #19

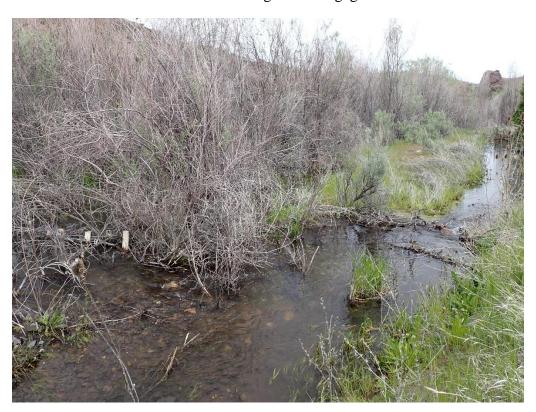
Below: View of structure #2 from different angle with engagement of side channel. Point #20

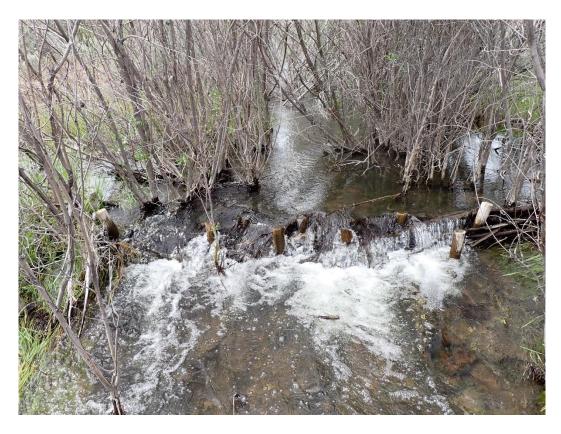
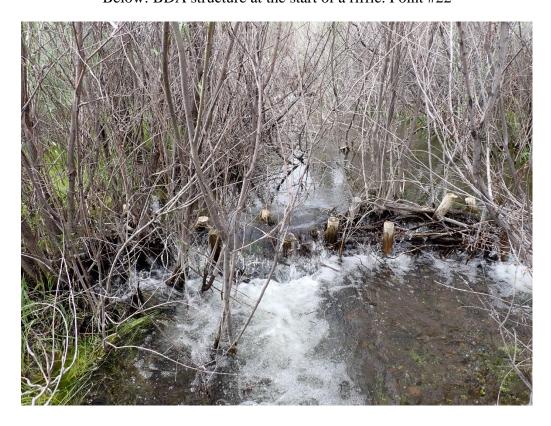
Above: View of BDA structure at bottom of a riffle. Point #21 Below: BDA structure at the start of a riffle. Point #22

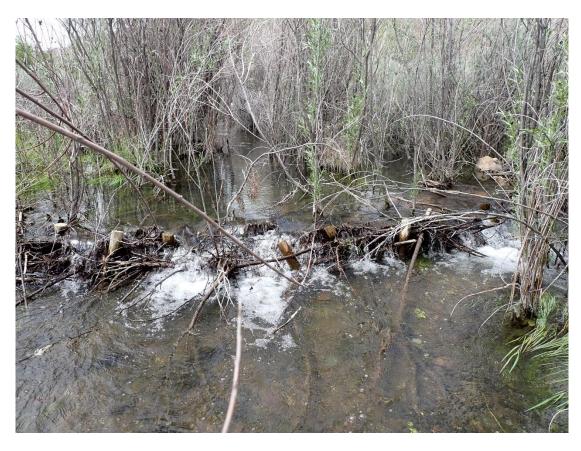
Above: BDA placed at the start of a glide. Point #23
