Middle Bear Creek BDA Restoration Phase 2

Post Implementation Status Report #1

Grant Number: 218-6027-16015

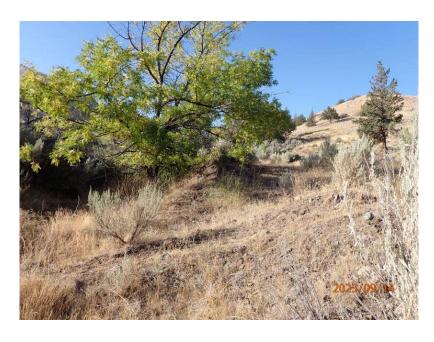
Spring Gulch #1 (2023) Vegetation restoration and soil erosion reduction efforts show continued success as restored vegetation persists on the landscape and is at expected successional stage. Additionally, it still maintains improved soil stability as there appear to be fewer wash out zones.

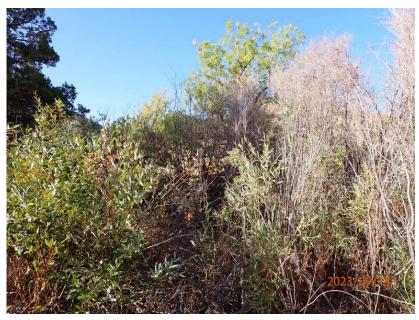
Spring Gulch #2 (2023) Riparian vegetation continues to thrive.

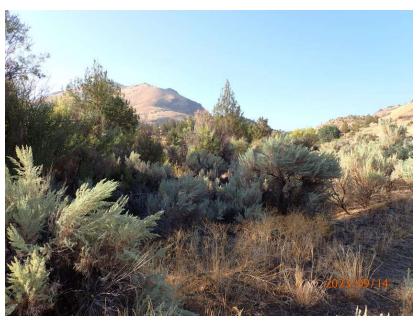
Spring Gulch #3 (2023) No surface water flow at the time of this report, however, vegetation continues to flourish.

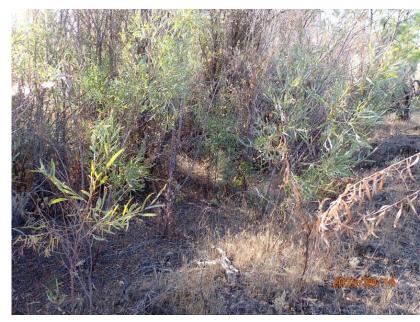
Spring Gulch #4 (2023) Vegetation still established as expected.

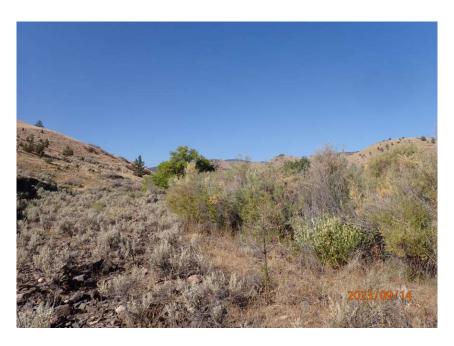
Beaver #1 (2023) Established vegetation aides in reduced erosion.

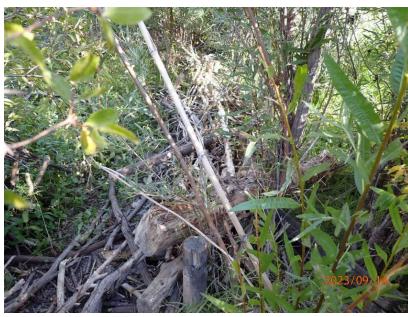
Beaver #2 (2023) BDA structure still established as expected.

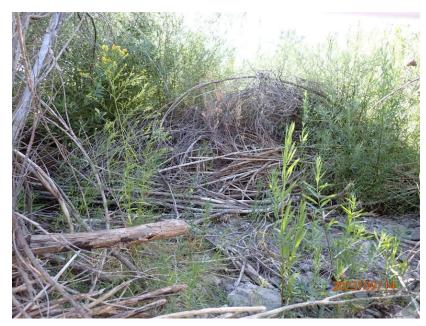
Beaver #3 (2023) BDA structure still established and collecting debris when surface is present.

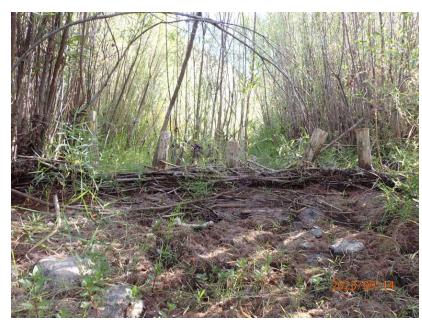
Beaver #4 (2023) BDA structure still established, capturing debris and sediment.

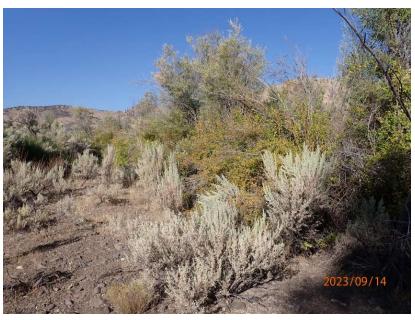
Beaver #5 (2023) Healthy vegetation thriving and providing erosion control.

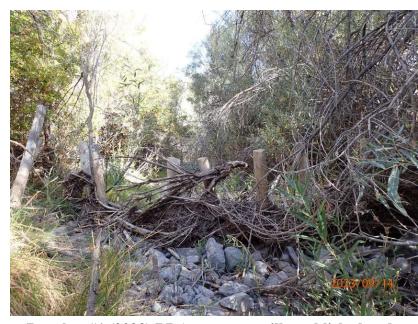
Rancher #1 (2023) BDA structure still established and capturing debris and sediment when surface water is present.

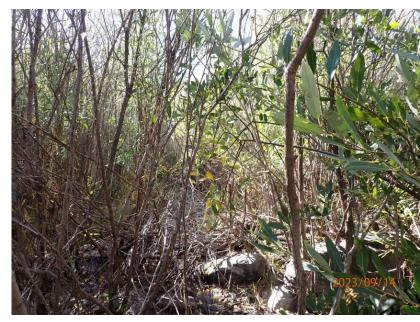
Rancher #2 (2023) Vegetation established as expected.

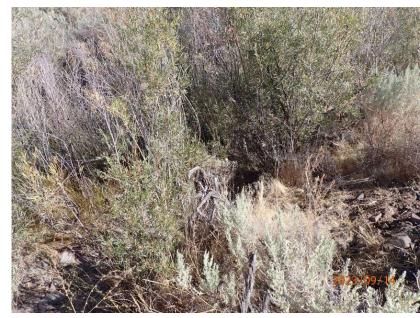
Rancher #3 (2023) No surface water present, however, vegetation still established.

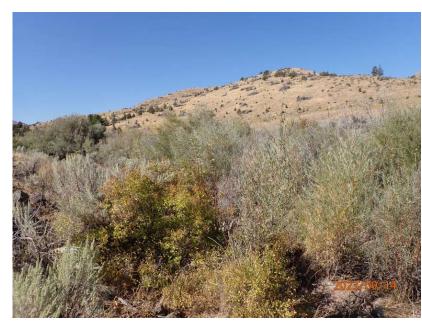
Rancher #4 (2023) Established vegetation still controlling erosion.
