Bridge Creek Holistic Restoration #1

Grant # - 216 – 6015 – 1213

Post Implementation Status Report #1

5/24/2021

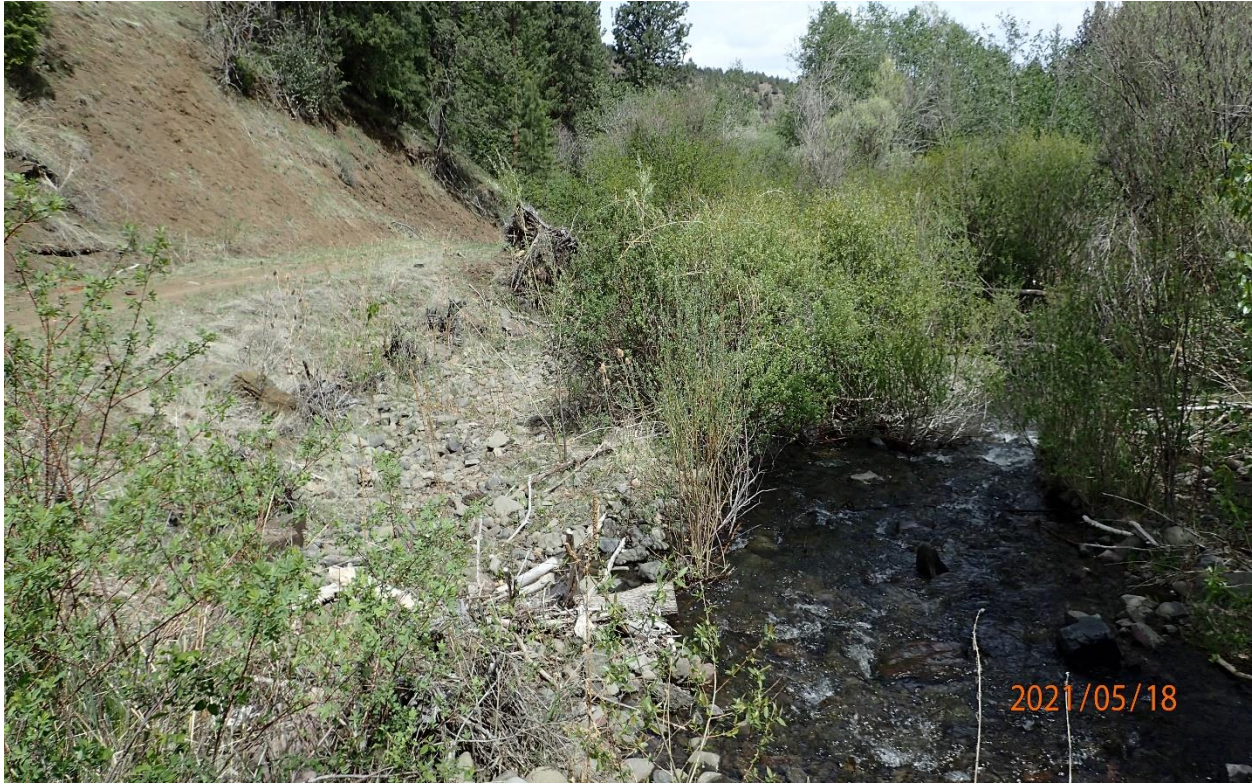
**Above:** Overview of bank stabilization and vegetation.

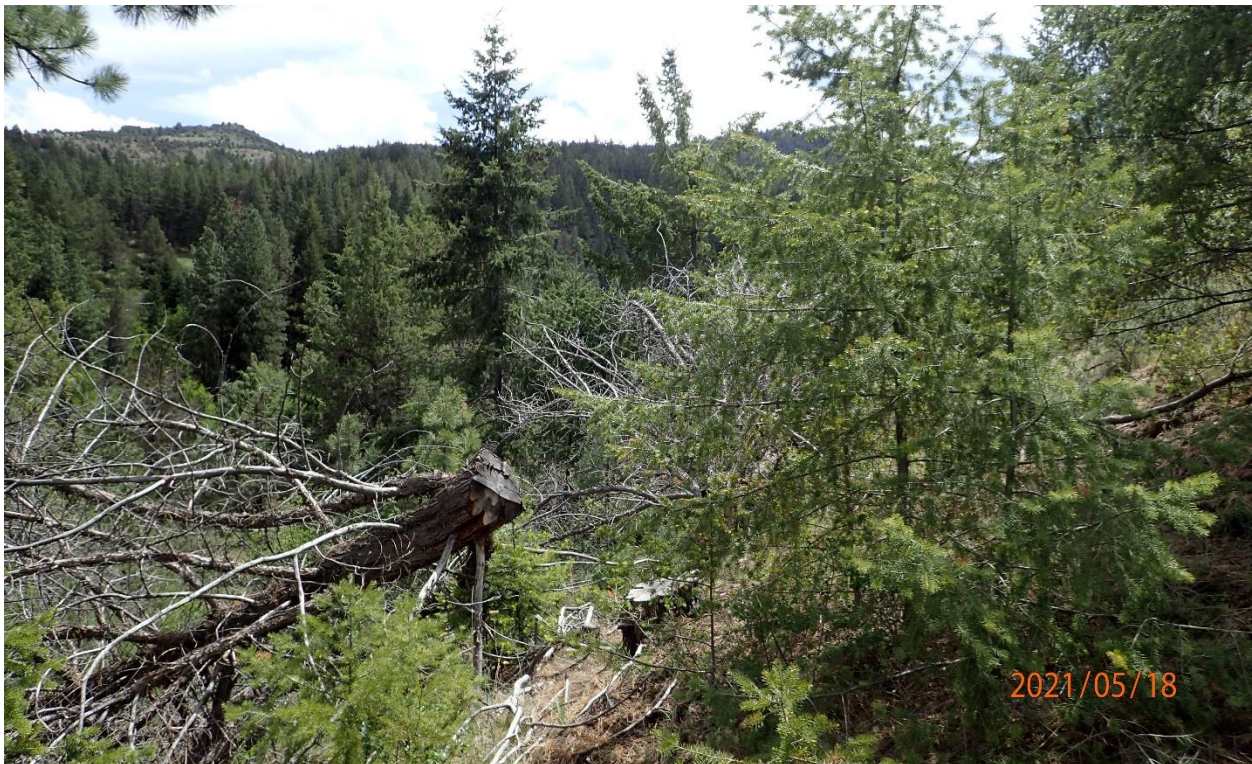
**Below:** Landscape view of juniper removal.

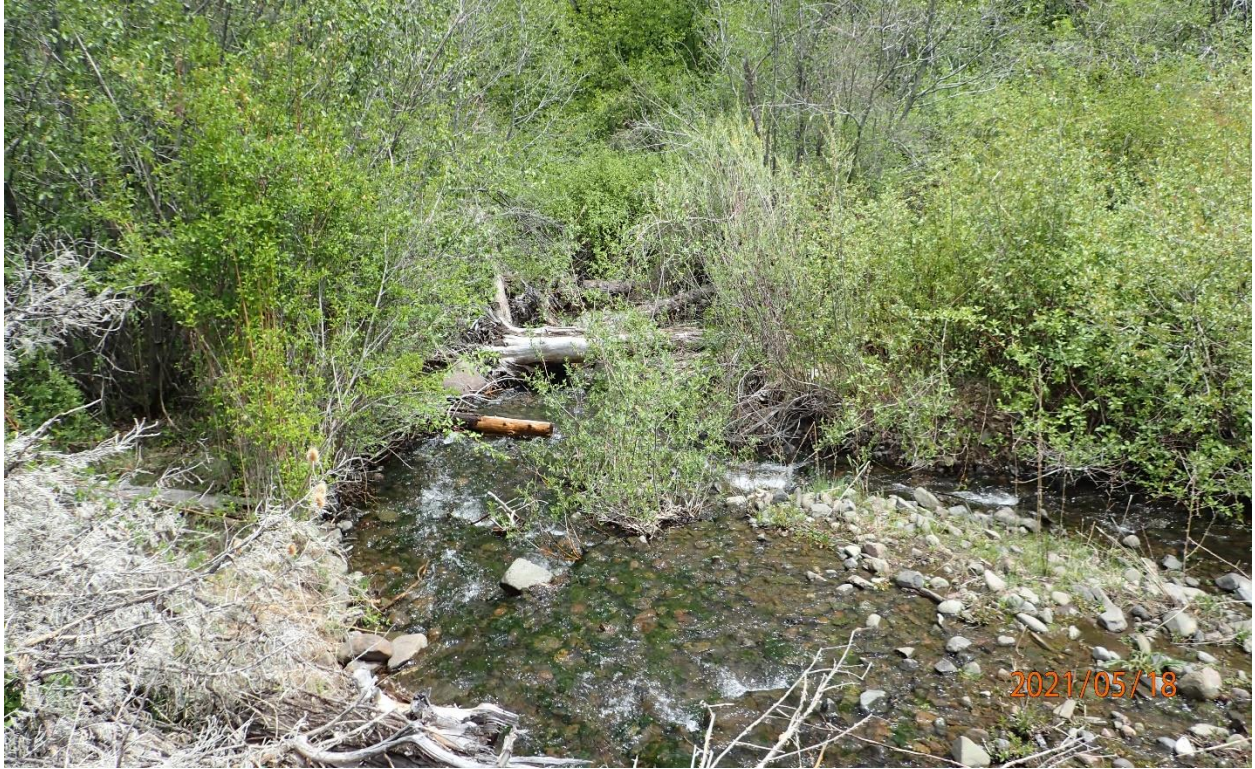
**Above:** View of LWD put instream to provide habitat complexity.

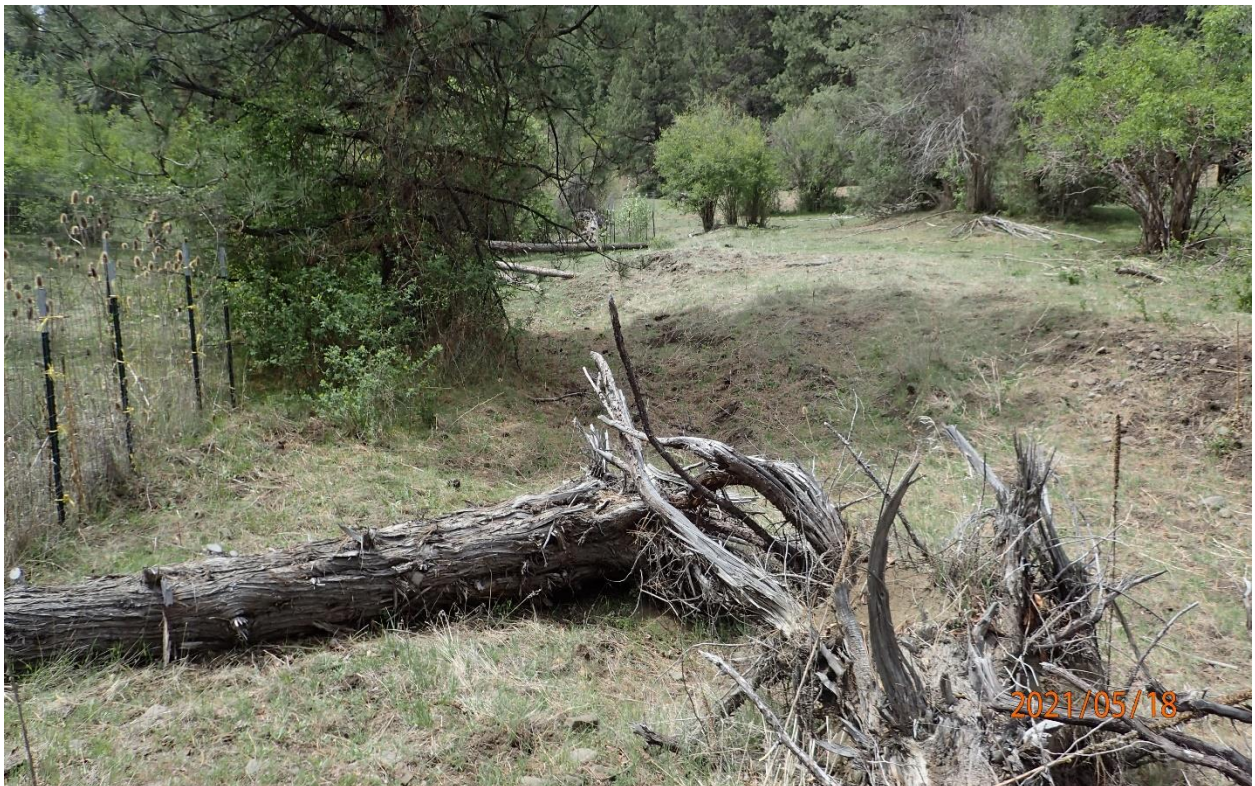
**Below:** Overview of LWD and Cottonwood cuttings protected by caging.

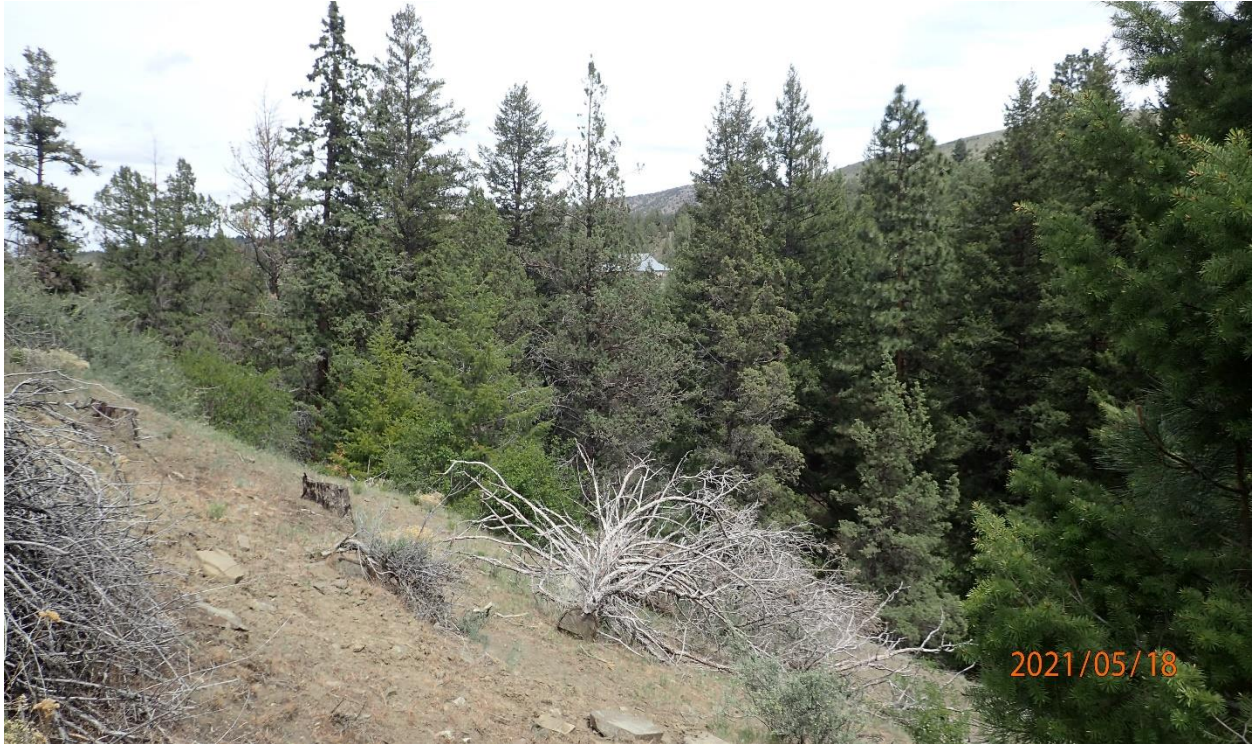
**Above:** View of juniper removal cut to NRCS specifications.

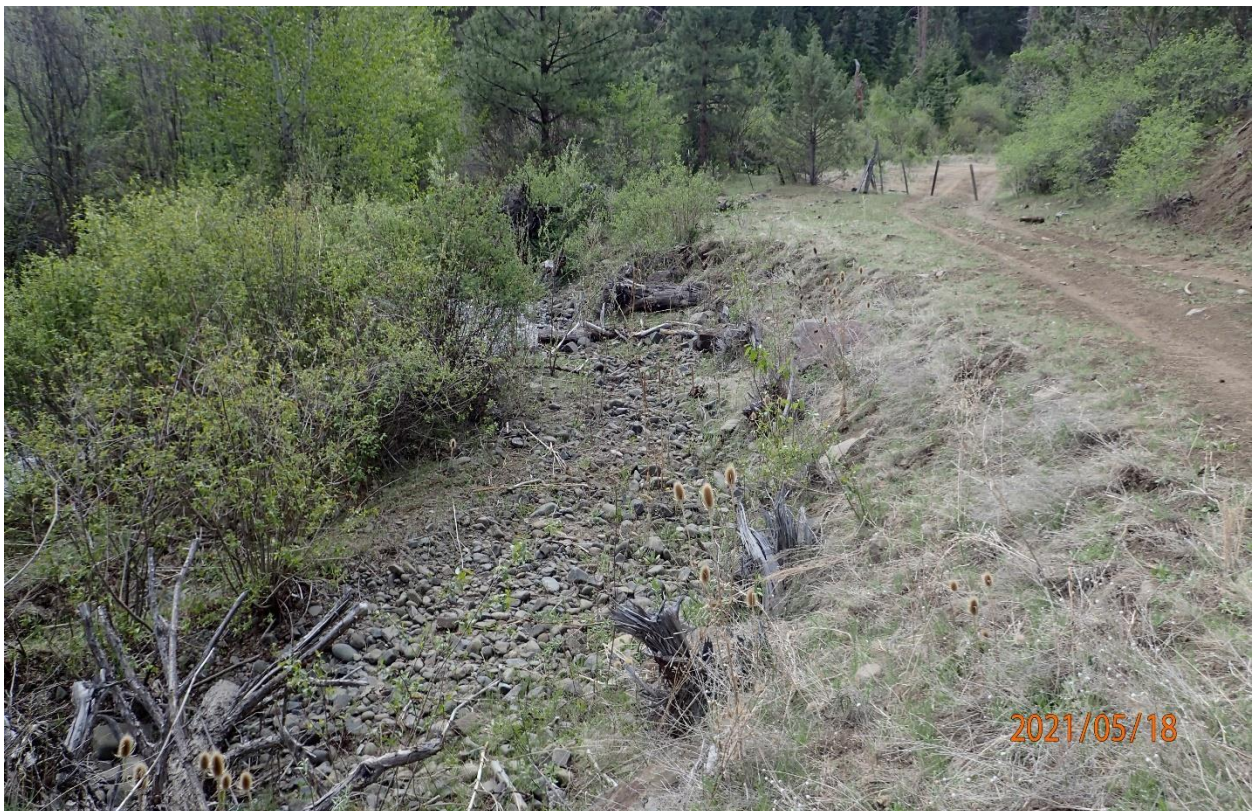
**Below:** Overview of bank stabilization and vegetation reestablishing.

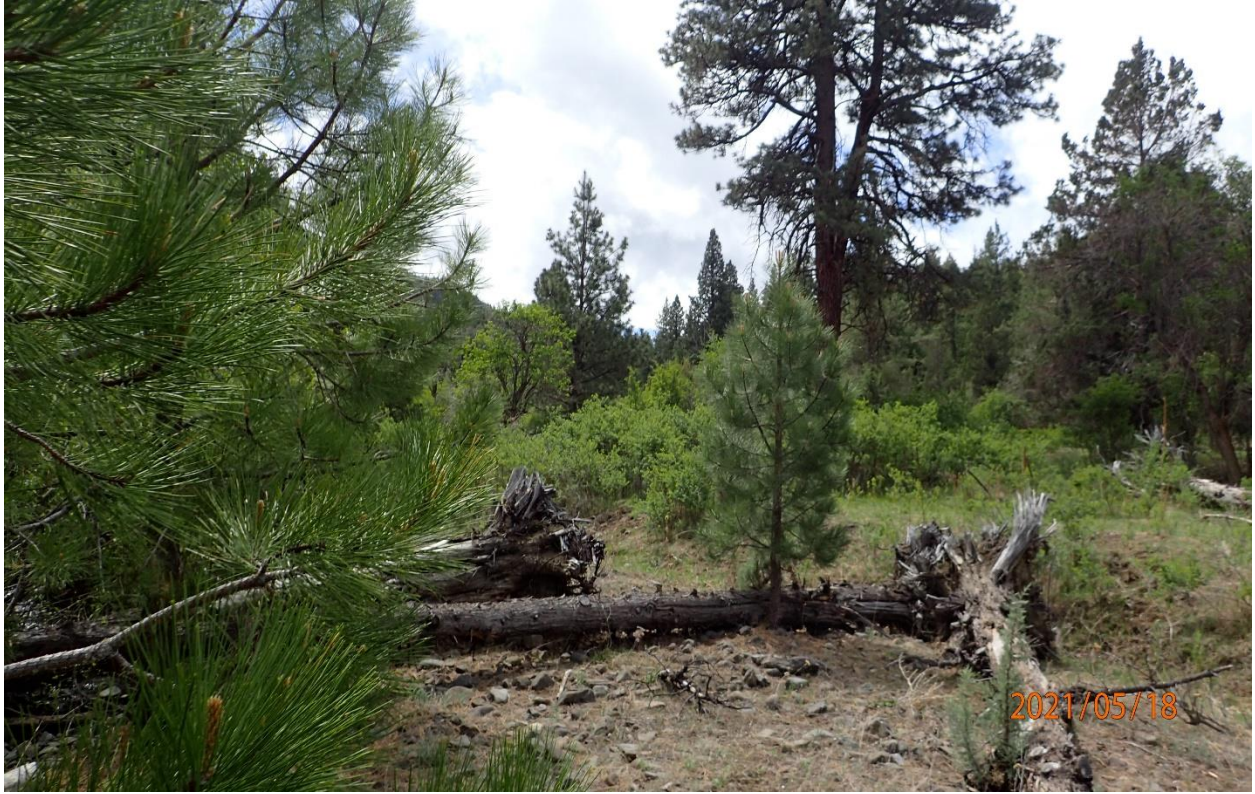
**Above:** Large Woody Debris placed throughout floodplain.

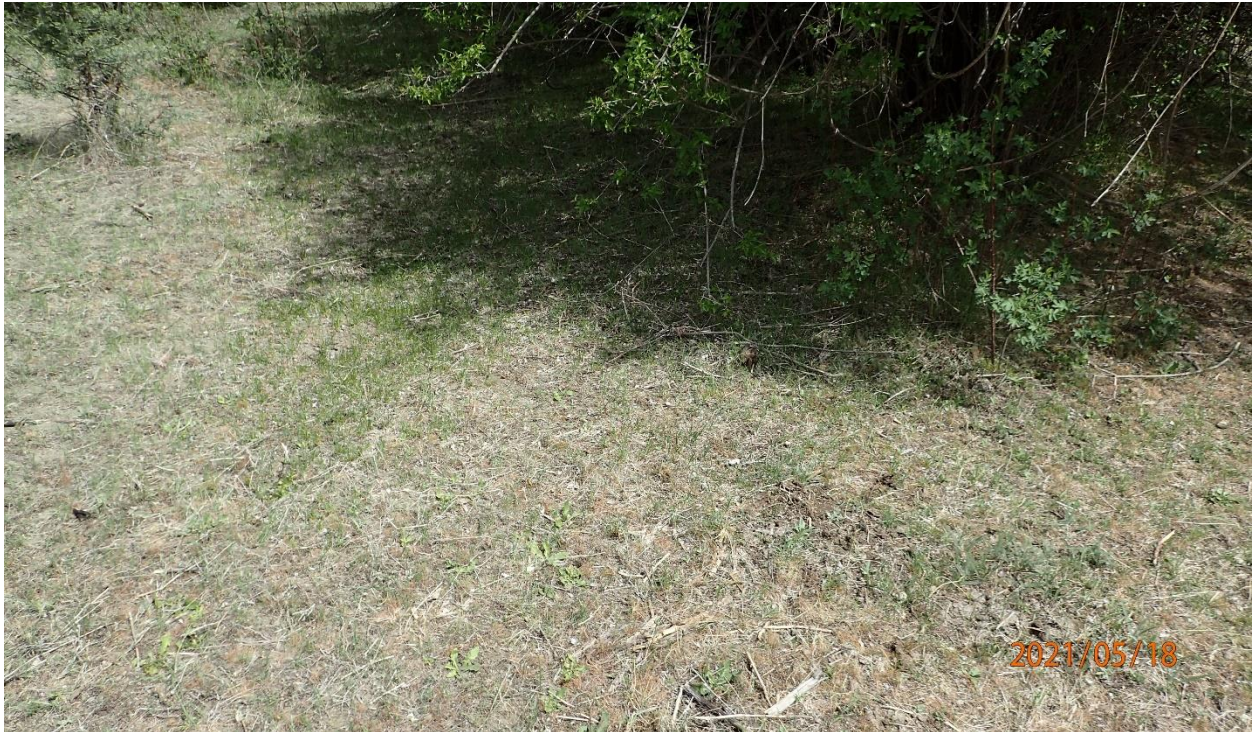
**Below:** View of floodplain with seeding.

1. The seeding will come back and was able to root and become established. In the photo in the shade by the riparian species, I know it's hard to see, but there is some stubble to the grass. Also, this last year has been poor in moisture for the winter and spring season, having a detrimental impact to all grasses this year. As there is one more monitoring report due in another two years, the vegetation cover should increase.
2. The last high flow event occurred in 2019. In a few of the LWD placements it was noticeable that some extra debris was caught and some sediment was moved through as the high velocity of the flow event reached the historic channel.

1. The photo that was submitted with the PCR (attached) appears to have some serious good growth; the photo you supplied with the PISR doesn't show any stubble, like the area has been grazed. Do you feel the seeded area will come back or was it grazed down so far that the seeding was not allowed to root and become established?
2. Did you see where any of the historic channels had been activated with high flows since implementation? Hard to tell from the photos.

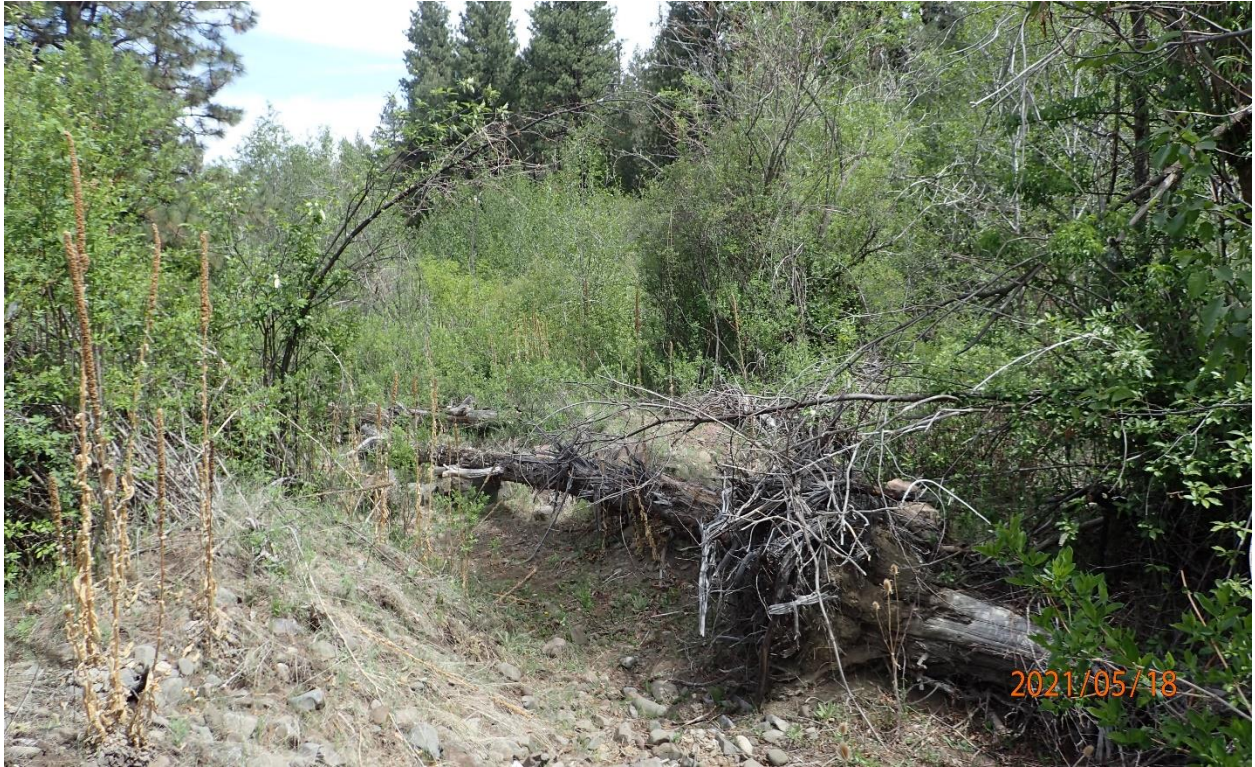
**Above:** Overview of old upstream berm dug out for historic channel.

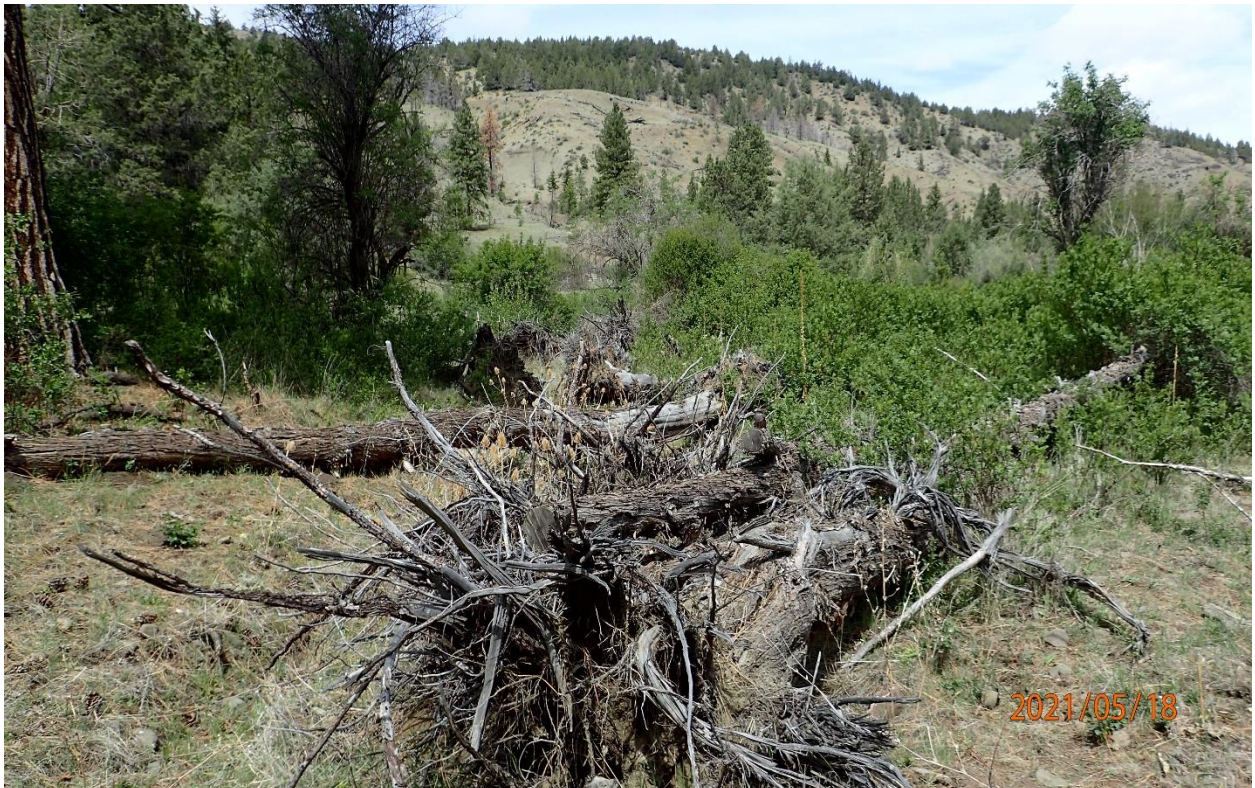
**Below:** View of LWD in historic channel.

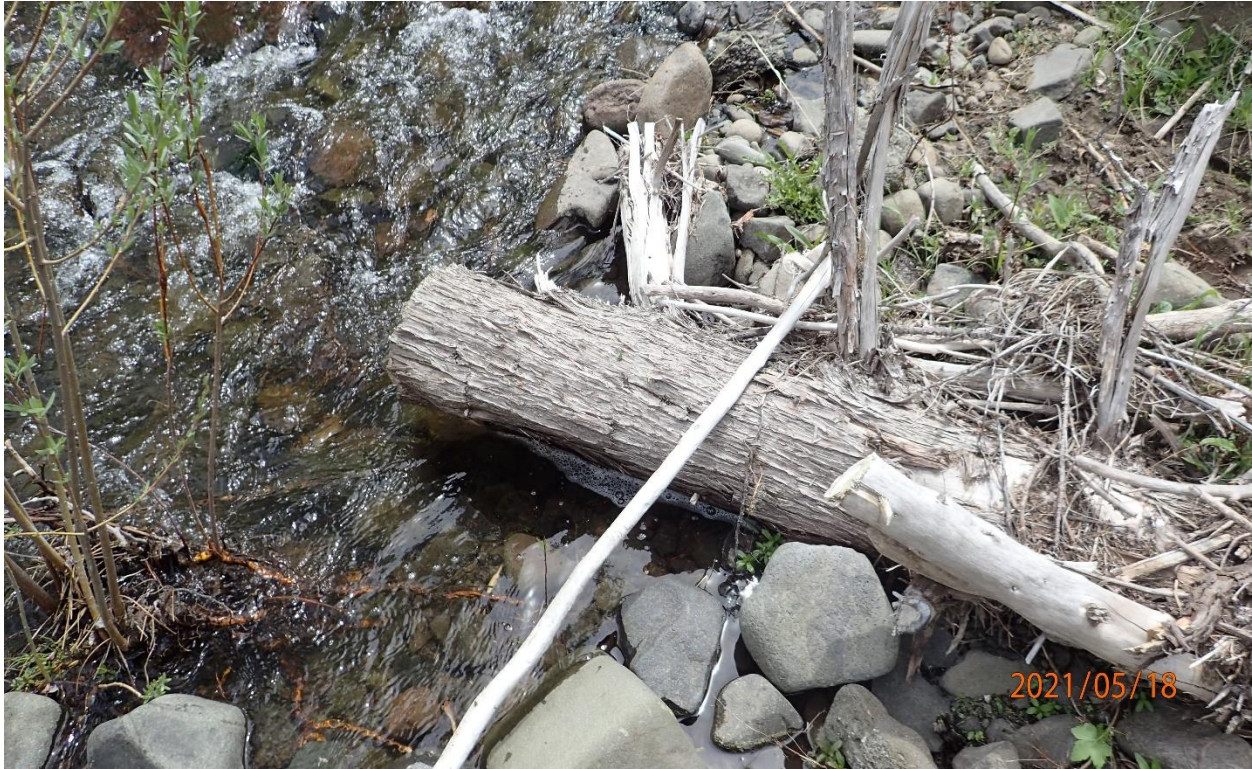
**Above:** Close up LWD providing habitat complexity.

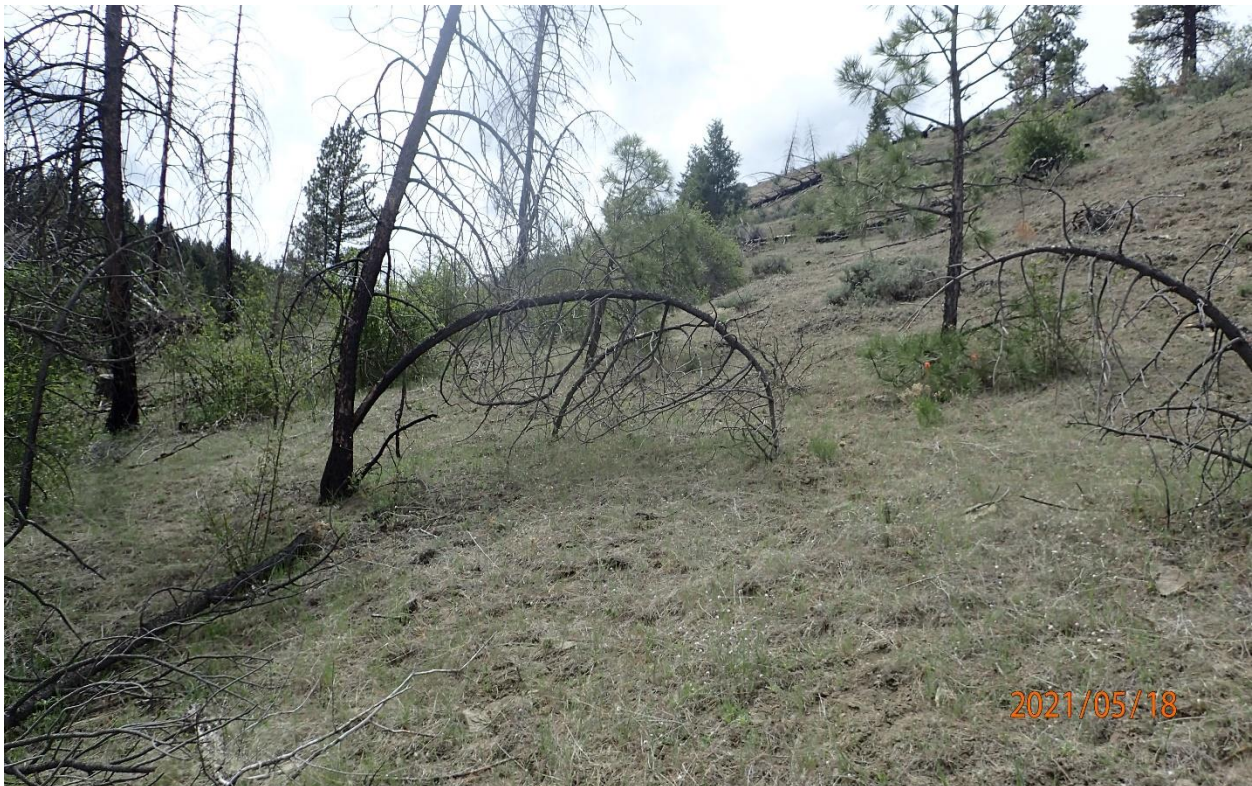
**Below:** Overview of juniper removal to NRCS specifications.

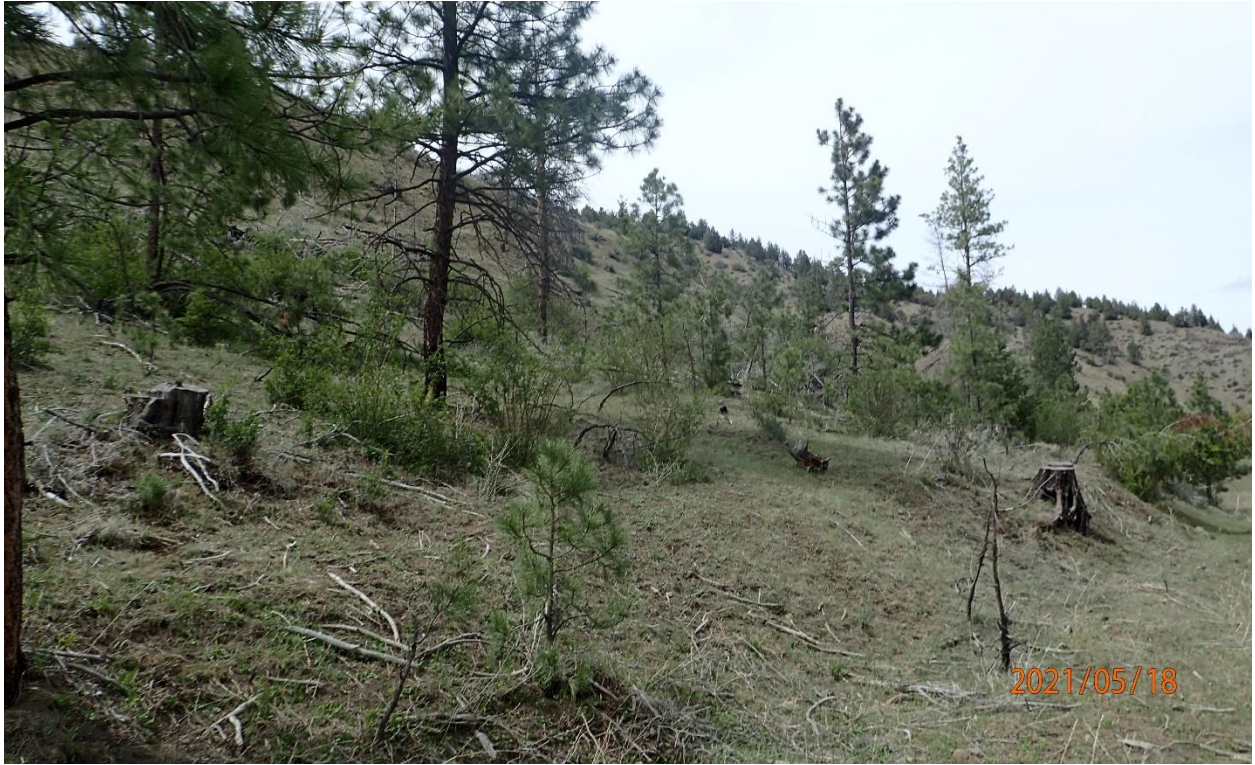
**Above:** Landscape view of juniper removal from Ponderosa Pine species.
