Bridge-Bear Phase 4

Grant Number- 218-6032-16061

Post Implementation Status Report #1

7/31/2023

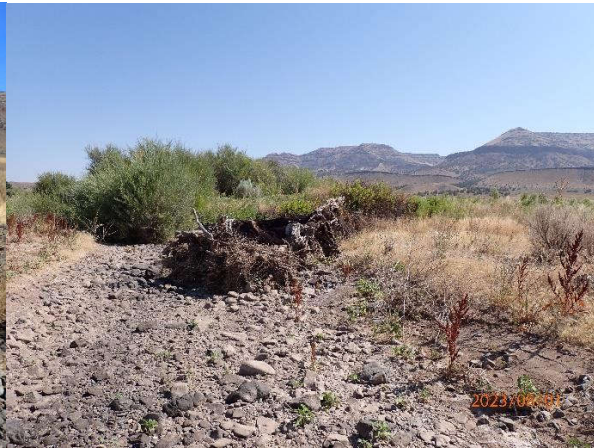
After: Large woody debris still in place.

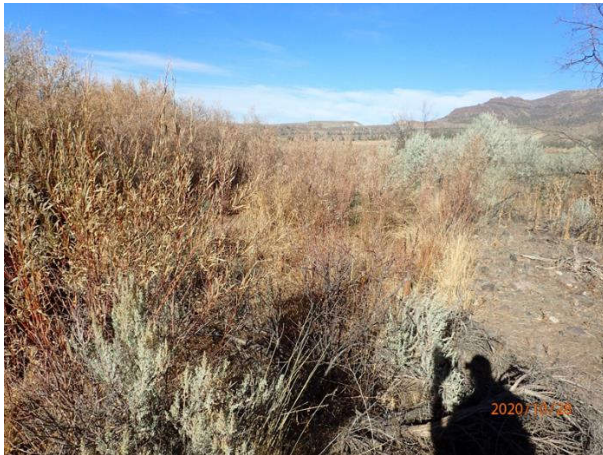
Above: Photo Point #20- View of BDA structure surrounded by riparian species.

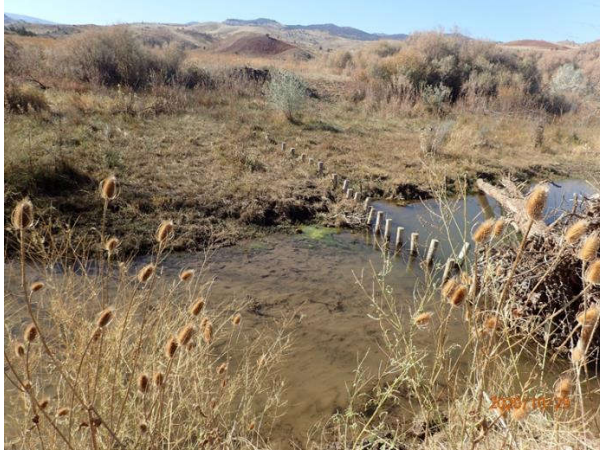
Above: Photo Point #25- Showing BDA structure across Bridge Creek and into the floodplain.

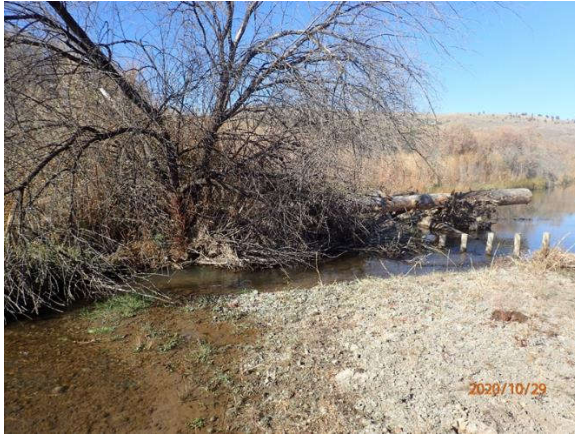
Above: Photo Point #29- View of BDA structure and large woody debris creating deposition.
