Middle Bear Creek BDA Restoration Phase 2

Post Implementation Status Report #1

Grant Number: 218-6027-16015

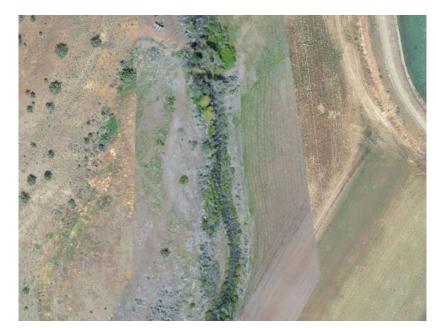
Photo Point #14

• Photo Points 14, 15, and 16 are all aerial photos. Due to conservation technician with certification for drone being on maternity leave the aerial photos are unavailable at this time.
