Bridge-Bear Phase 4

Grant Number- 218-6032-16061

Post Implementation Status Report #1

7/31/2023

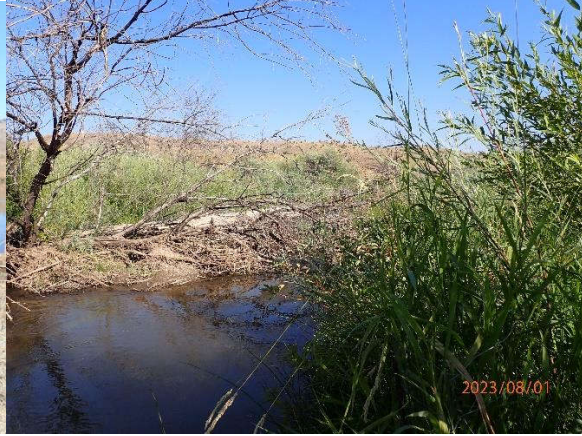
After: BDA with Beaver activity, and large woody debris still present.
